Liberia Electricity Regulatory Commission

LIBERIA ELECTRICITY CORPORATION DISTRIBUTION SERVICE AREA (MONTSERRADO COUNTY) INSPECTION REPORT

The Technical Regulations Directorate (TRD)

August 2025

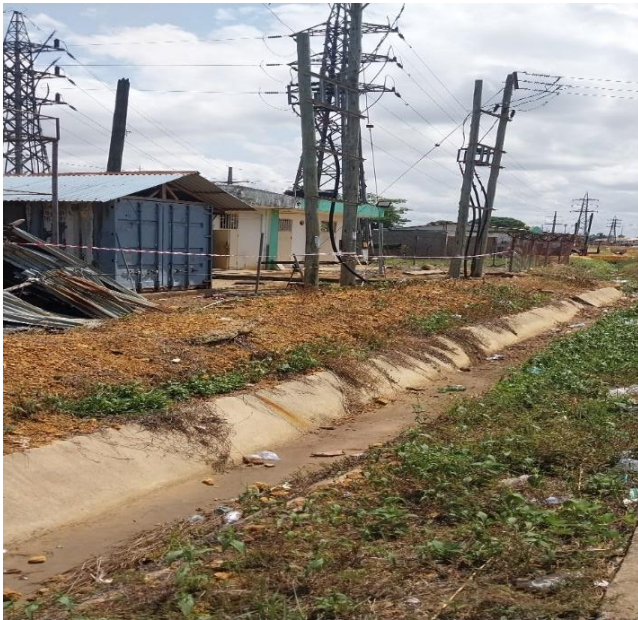
Paynesville Substation

- ✓ The fire alarm system is disconnected.
- ✓ The Substation transformer blast wall is cracking, which is an identified Hazard.
- ✓ Some bays and equipment are not labelled in the switchyard.

- ✓ The outdoor lighting distribution box cover in the switchyard does not lock.
- ✓ There are several visible cracks on the civil structure of the new control building.

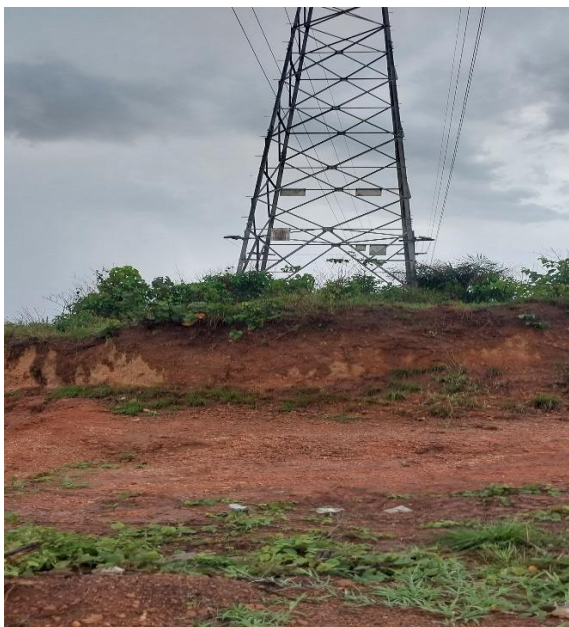
- ✓ Most of the Paynesville - Mt. Coffee 66 kV tower foundations are being undermined by illegal soil mining activities.
- ✓ Encroachments are being made in all the corridors, and new structures are being built under the 66 kV overhead lines. Critical areas are the Paynesville - Kakata 66 kV Feeder, in Peace Community and King Farm where people have started building very close to some towers (66 kV) and putting blocks around some. Additionally, along the Paynesville - Congo Town 66 kV, one tower footings are being used for a vehicle parking and around other towers commercial activities were observed to be taking place.

Paynesville - Mt. Coffee 66 kV Tower

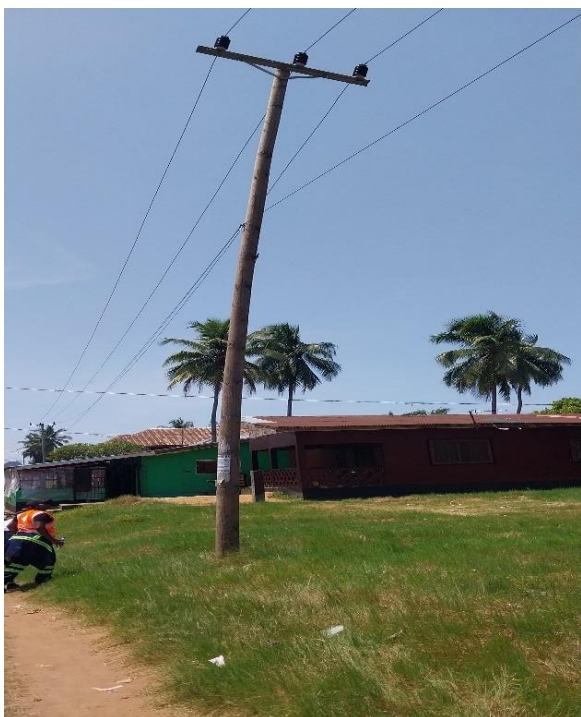
- ✓ Wooden poles of smaller dimensions during construction were seen installed at light and heavy-angle areas. As a result, the mechanical stability and structural balance of the poles are failing. This situation is observed prevalent in places where smaller subcontractors' companies executed projects. for example, from the Duport Road junction using the bypass to Cool FM, Nimba United Community to name a few.

Leaning MV Pole at the Back of Kool FM

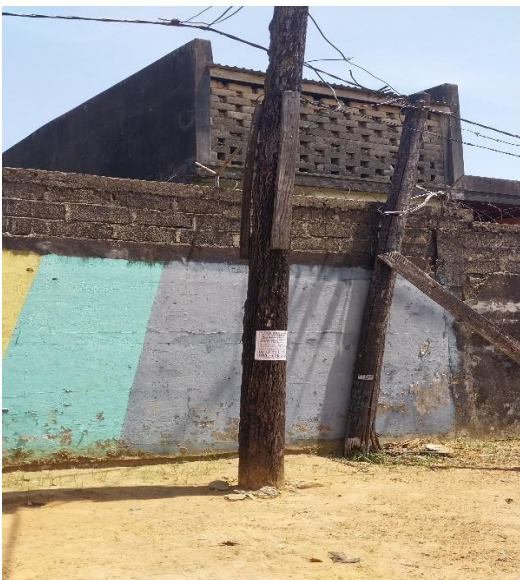
- Congo Town Feeder at the back Zone 5, there are leaning LV poles, and the LV conductors are attached to palm trees for support.
- ✓ On the Duport Road - Congo Town Feeder, in the GSA Road and Kissi Camp (Bhofal Chambers Road) Communities, low LV cables, leaning poles, and rotten poles were observed.

Deplorable LV from LBS to GSA Road

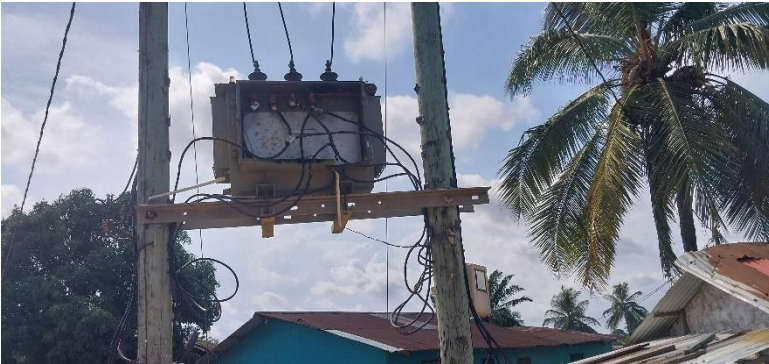
Police Academy, Ruth Perry Community

- ✓ Paynesville - Redlight Feeder at the Police Academy Watch Tower, there is a burnt H-framed transformer pole.
- ✓ Paynesville - Redlight Feeder, Police Academy, Ruth Perry Community, one 200 kVA transformer attached LV distribution cable termination housing cover has been removed and is exposed raising safety concerns.

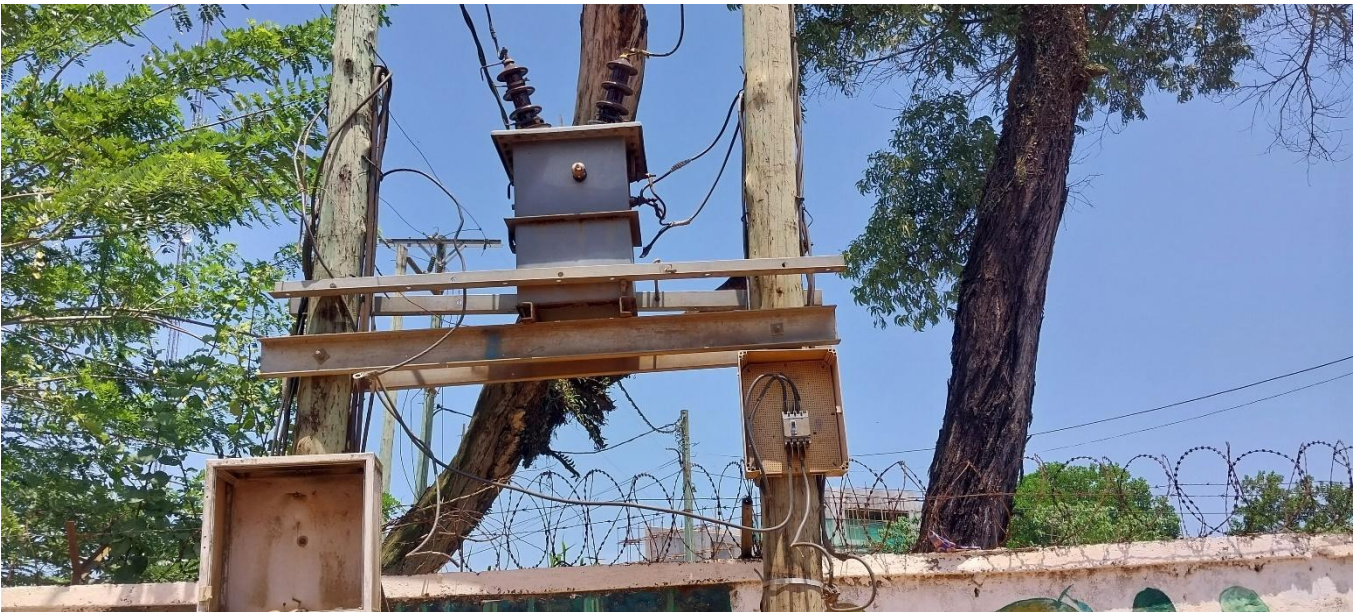
- ✓ On the Duport Road - Congo Town Feeder, LBS Community (Lover Street), there is a damaged 50 kVA transformer.
- ✓ On the Duport Road - Congo Town Feeder, in the LBS Community around PYJ Church, vegetation has over taken the transformer station.

Damaged Transformer Breaker at LBS

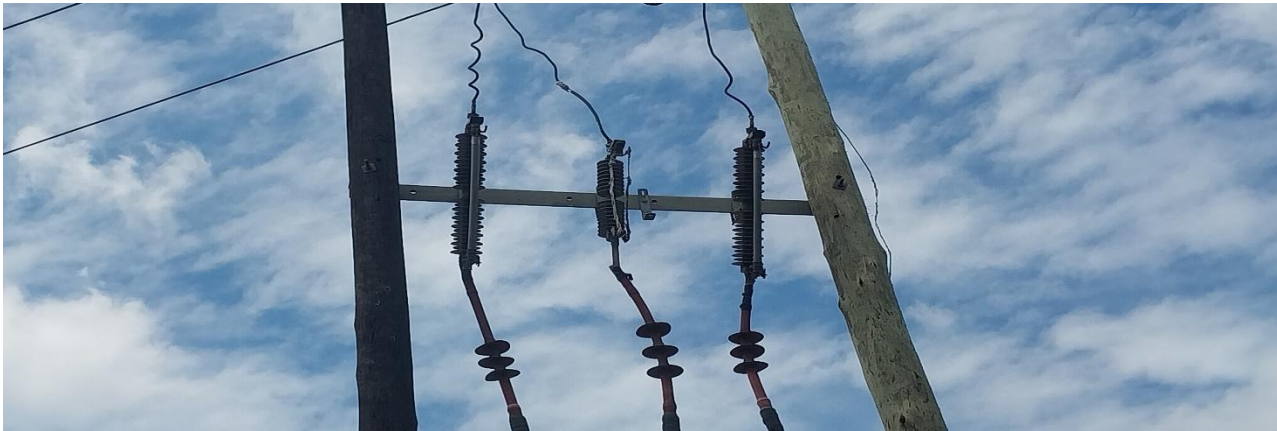
Middle Phase of Cut-Out Fuse Bypassed at Gardnerville Substation

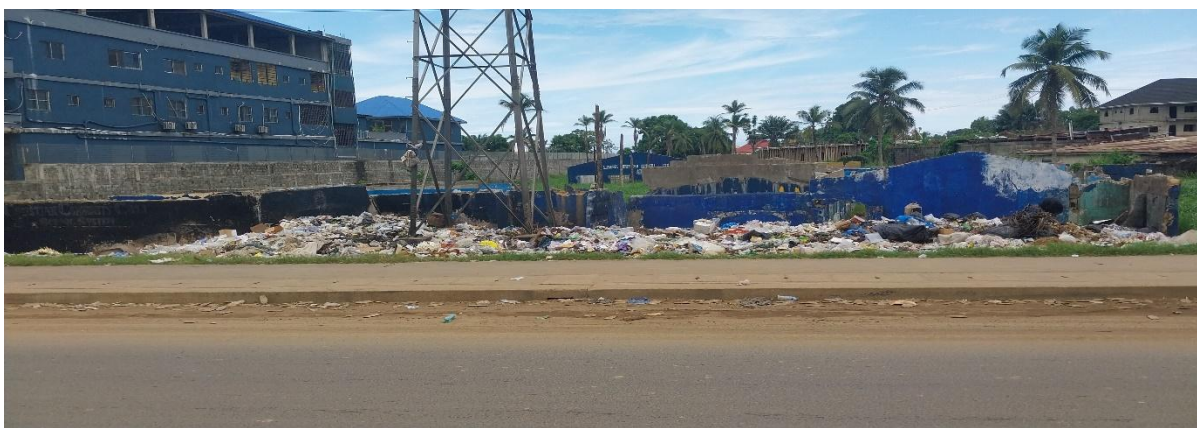
Somalia Drive, Japan's Freeway

- ✓ Substation are in a good state of operation, and vegetation management complies with regulatory standards.
- ✓ Along the Somalia Drive on Japan's Freeway, one tower spot has become a dump site.

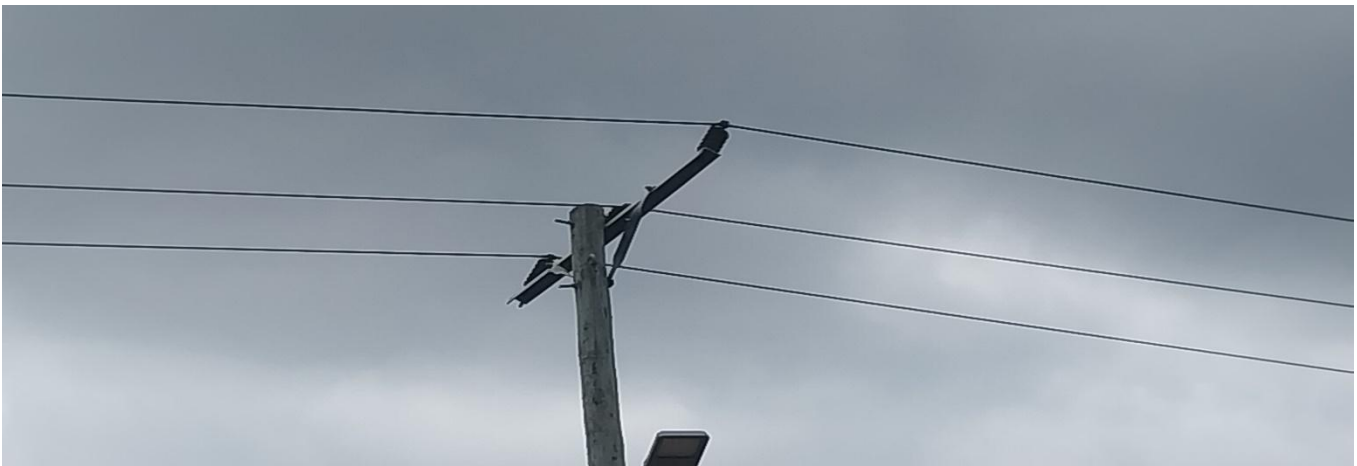
Leaning Cross-arm with Insulator on the Somalia Drive on Gardnerville - Stockton Creek Feeder

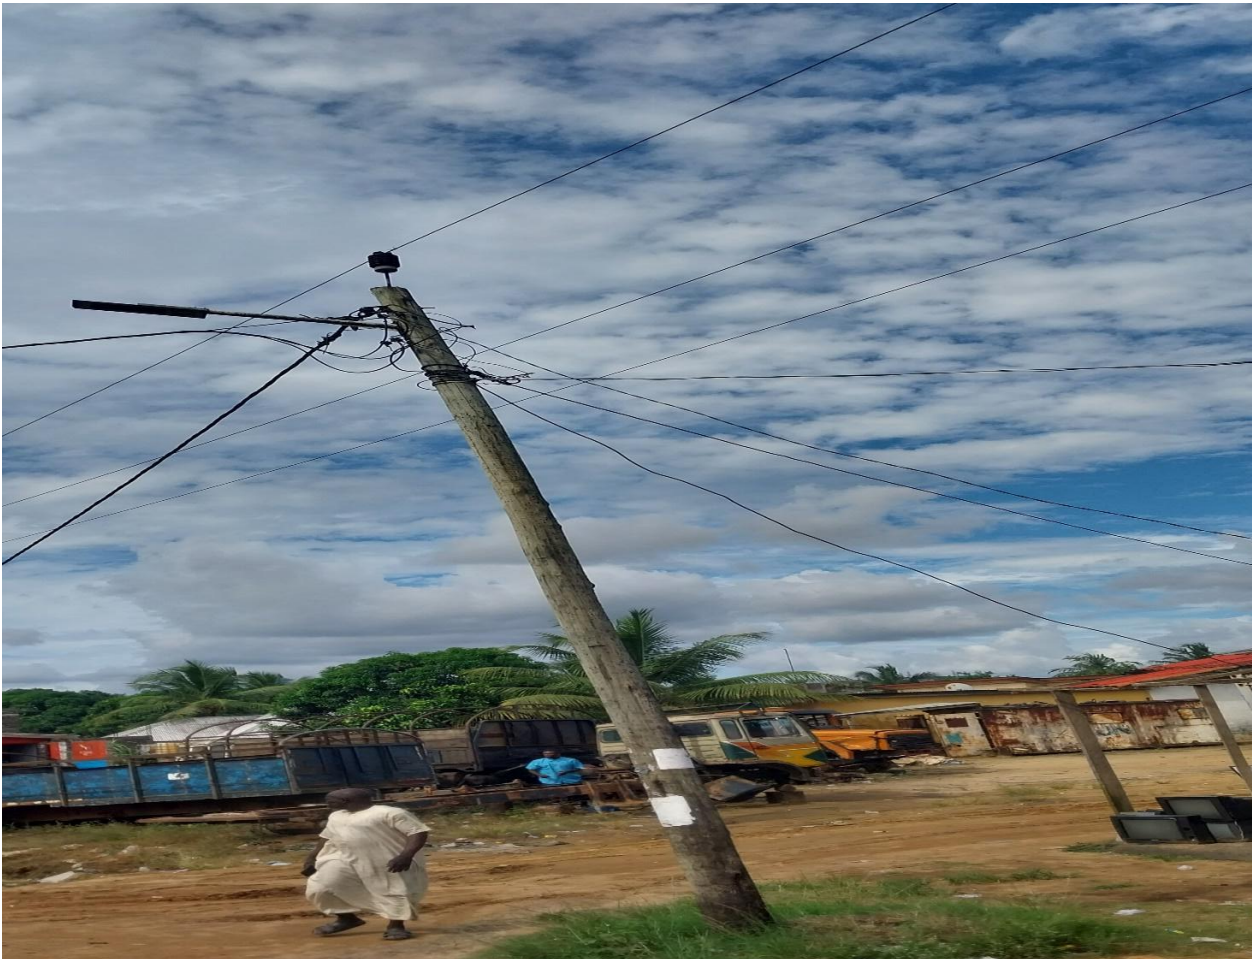
Leaning LV Pole with Insulator at the Top of the Pole

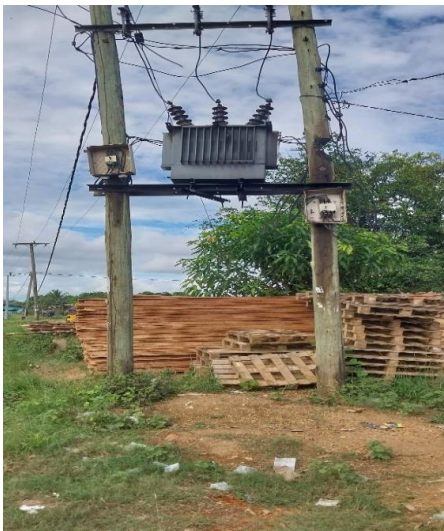
Burnt Transformer Pole

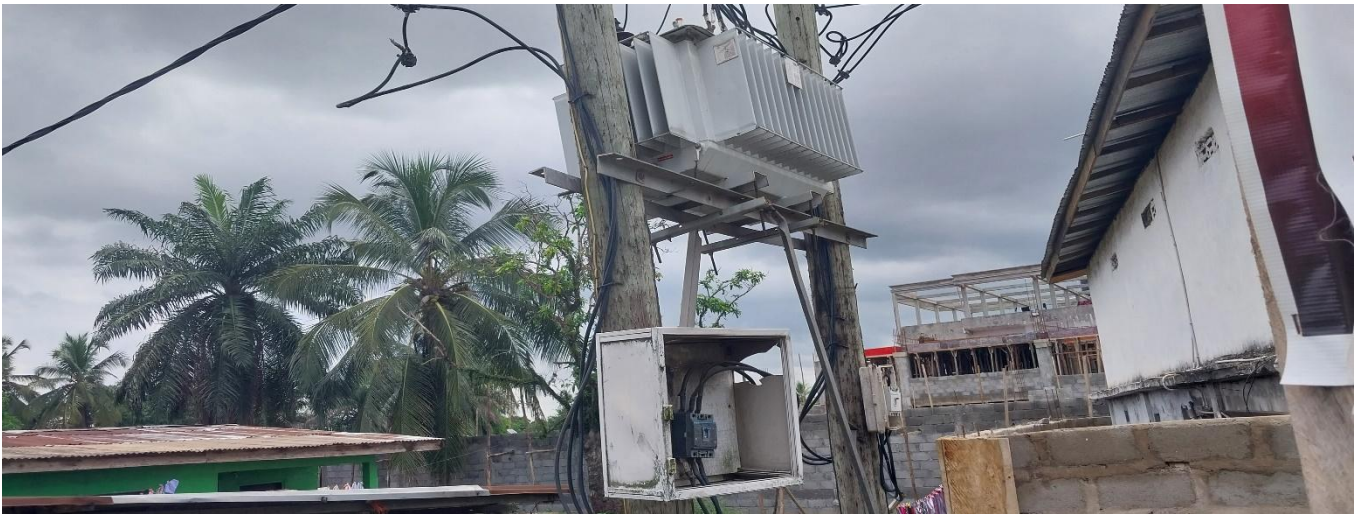
Damaged Enclosures

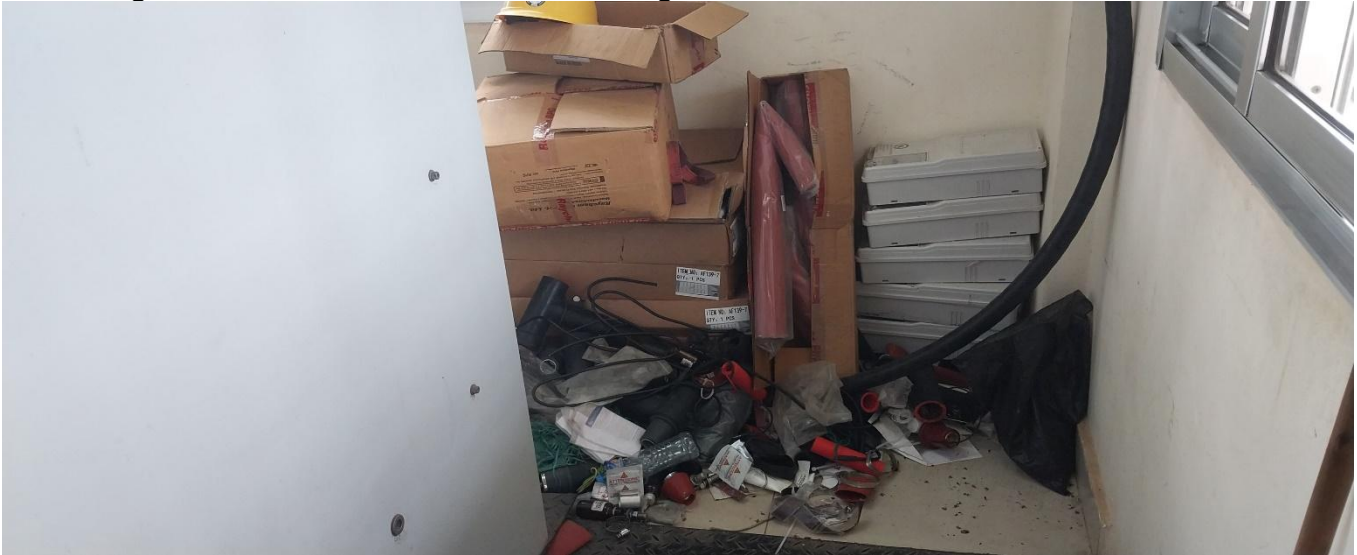
Materials Kept at the Back of Medium Voltage Switchgear at the Gardnerville Substation

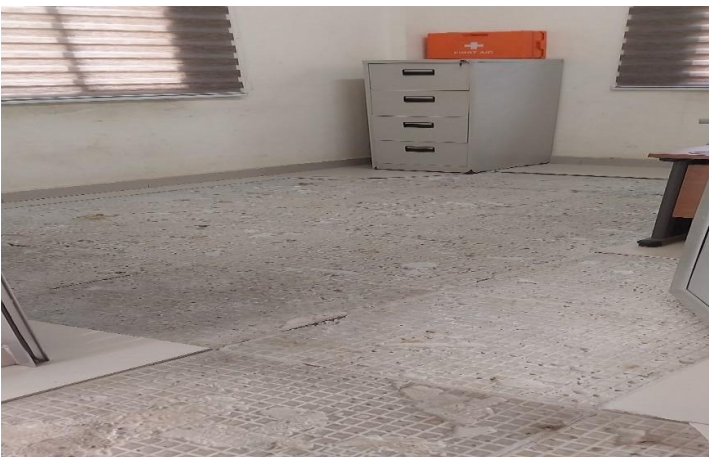
Damaged Floor/Tiles in Stockton Creek Control Room

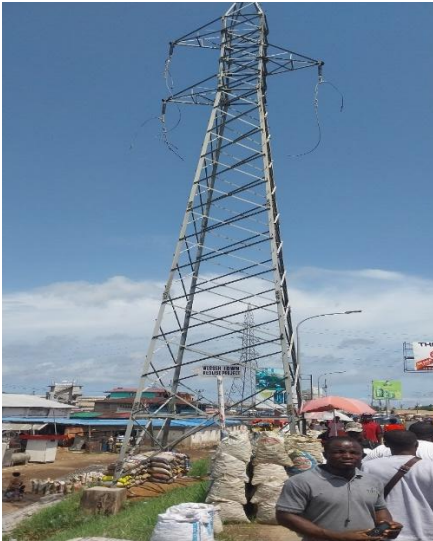
- ✓ There is a decommissioned 66 kV tower at Stockton Creek that needs removal.

De-commissioned Tower at Stockton Creek

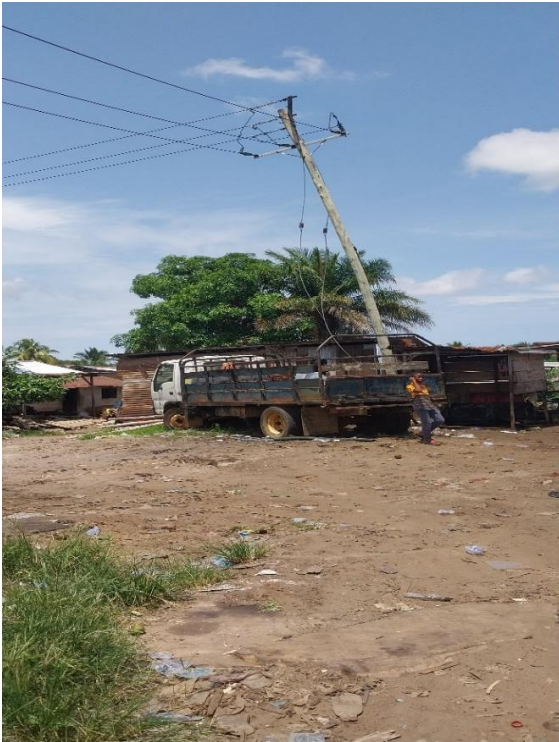
- ✓ Along the Somalia Drive, in the vicinity of Battery Factory junction, there is a signboard close to the MV lines and a leaning MV pole.

Leaning MV Pole from Diverted Lines from the Main Somalia Drive

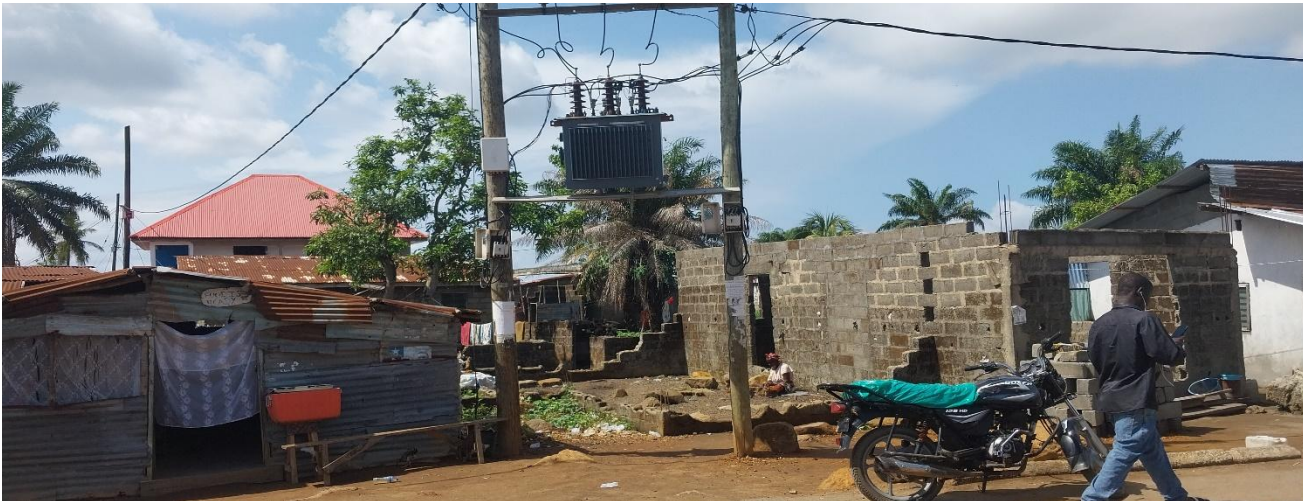
Damaged Transformer Breaker Enclosure

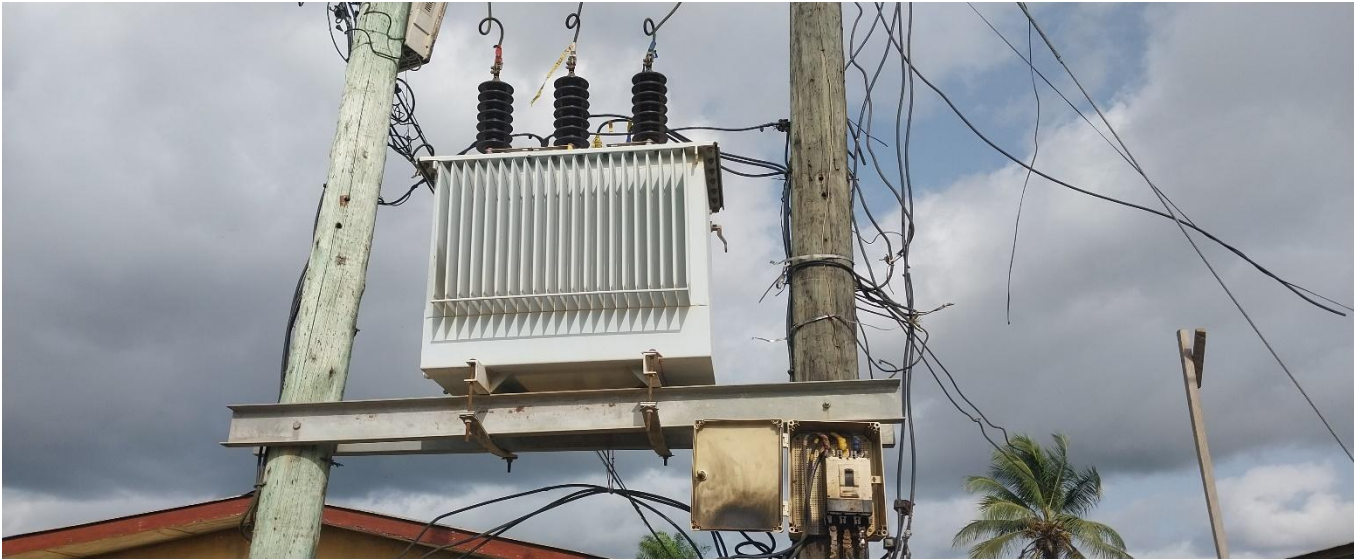
Damaged Transformer Breaker Enclosure

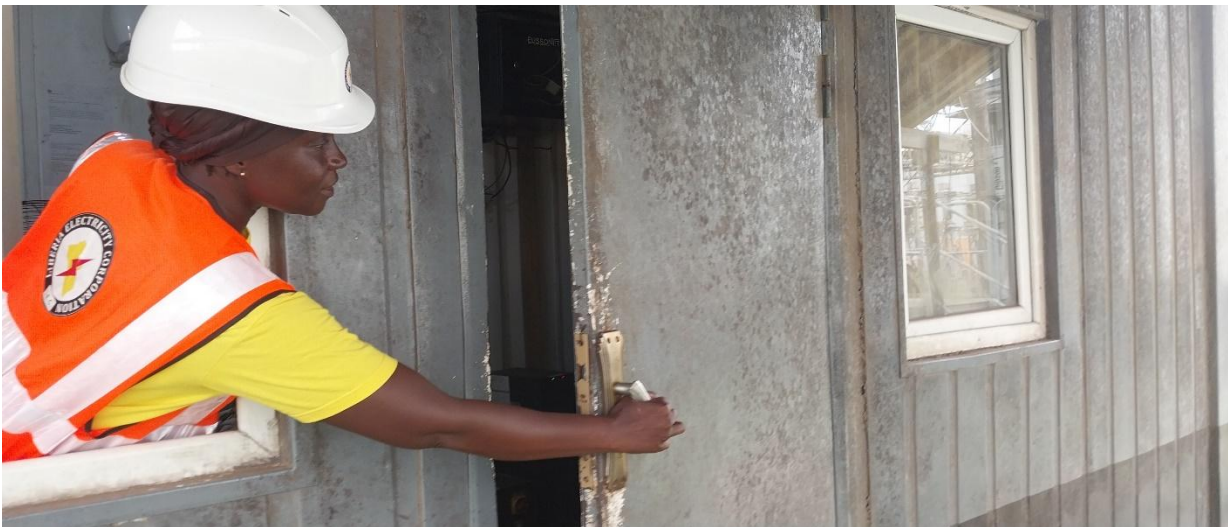
Operator Office Only Open from the Outside

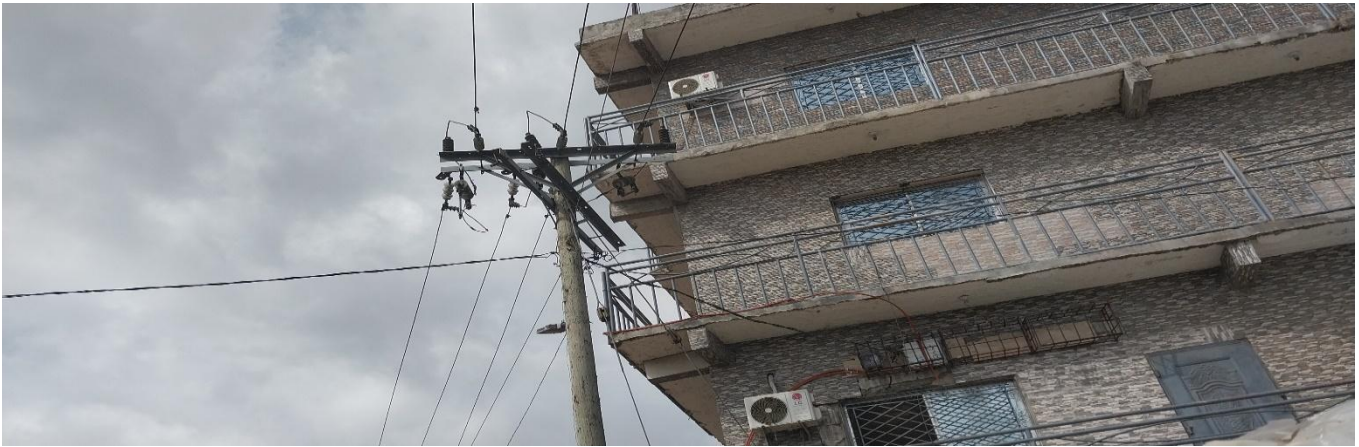
MV Very Close to Structure

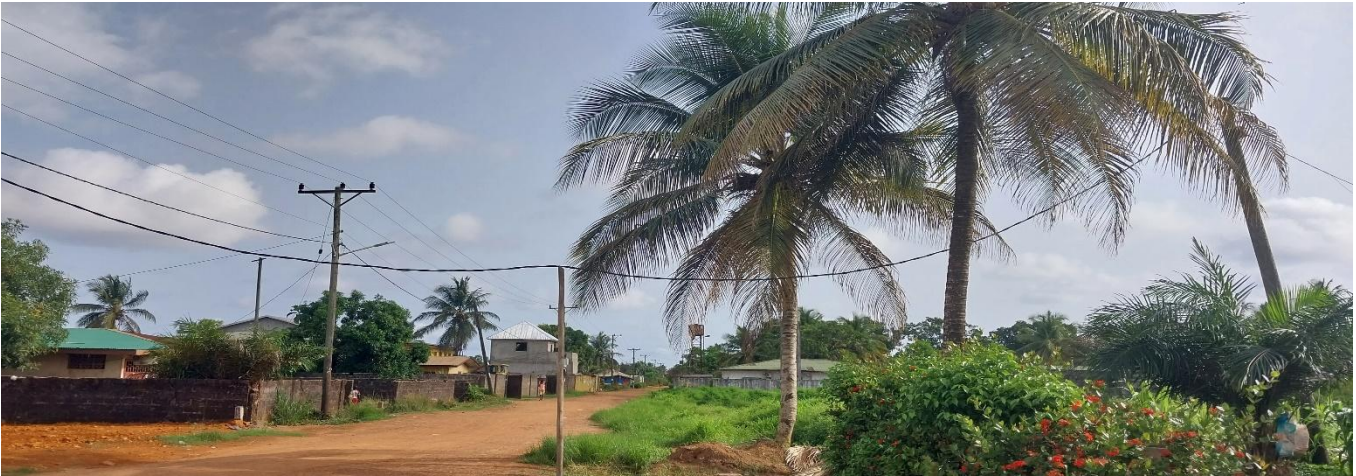
- ✓ On the Express Feeder, in Forkay Town, Green Land Community, there are poorly maintained LV network and rotten poles.
- ✓ On the Express Feeder, in Caldwell, Lajor, leaning LV poles, poorly maintained LV network, and old enclosures are still installed on poles.
- ✓ On the Express Feeder, on Benson Street, there are leaning LV poles and poorly maintained LV network.

Poor LV Network

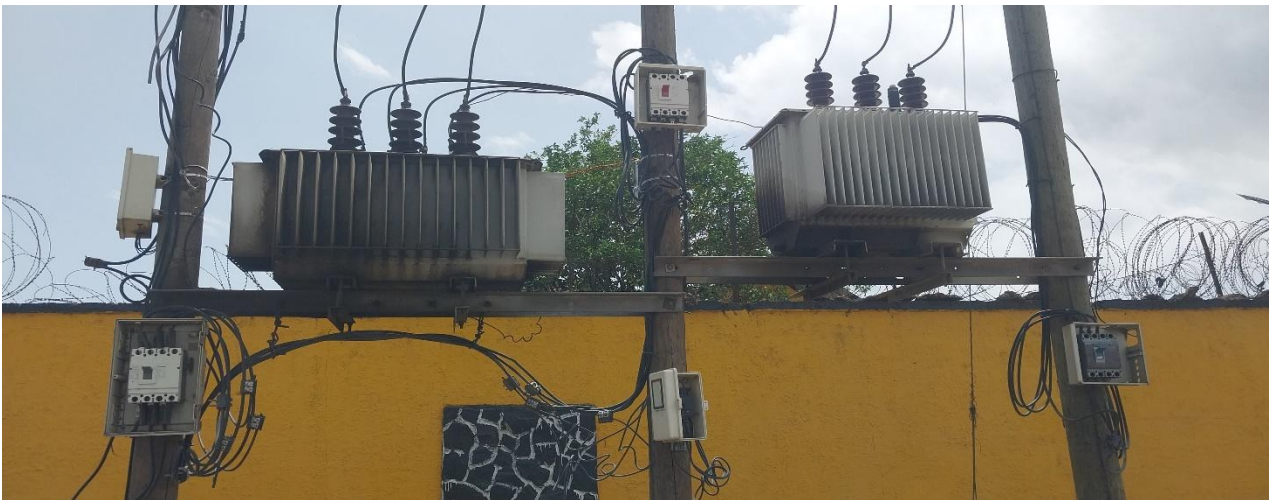
Damaged Enclosures at NAFAA

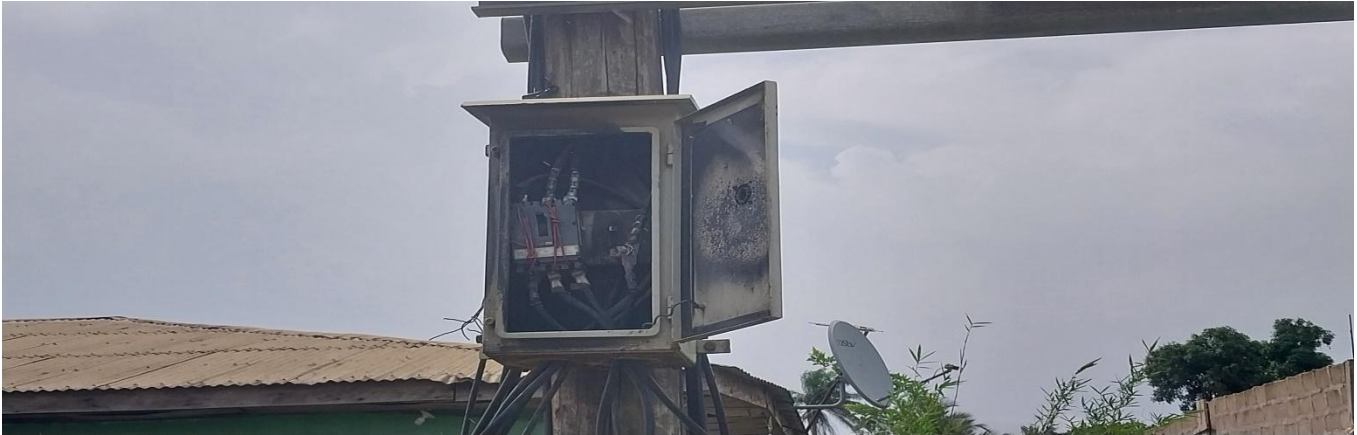
Burned Breaker

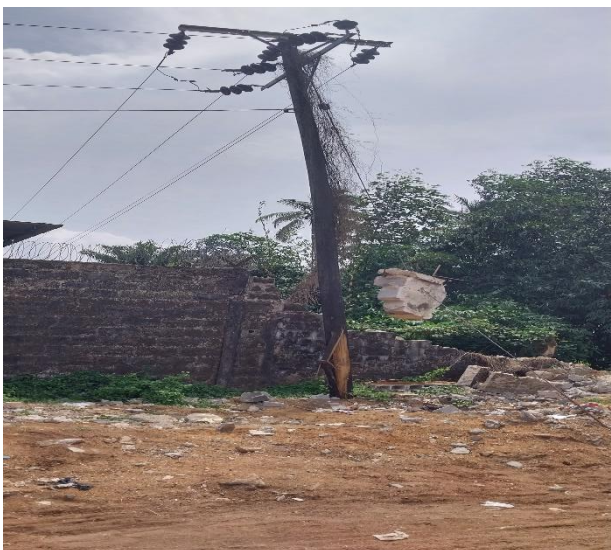
Concrete hanging on a pole

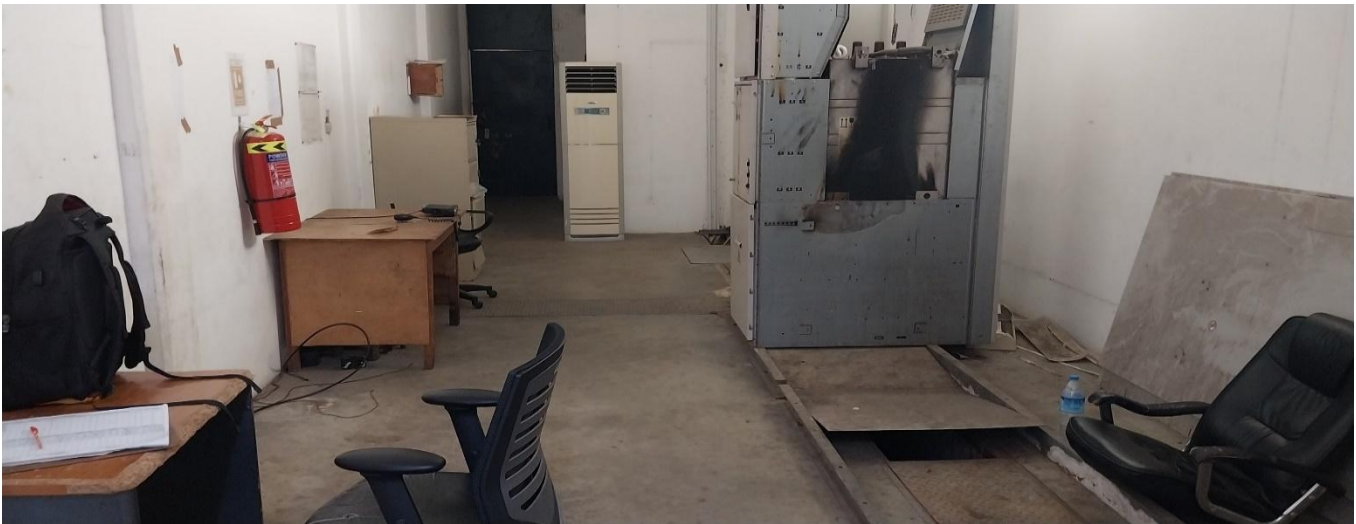
Old Desks and Cubicles

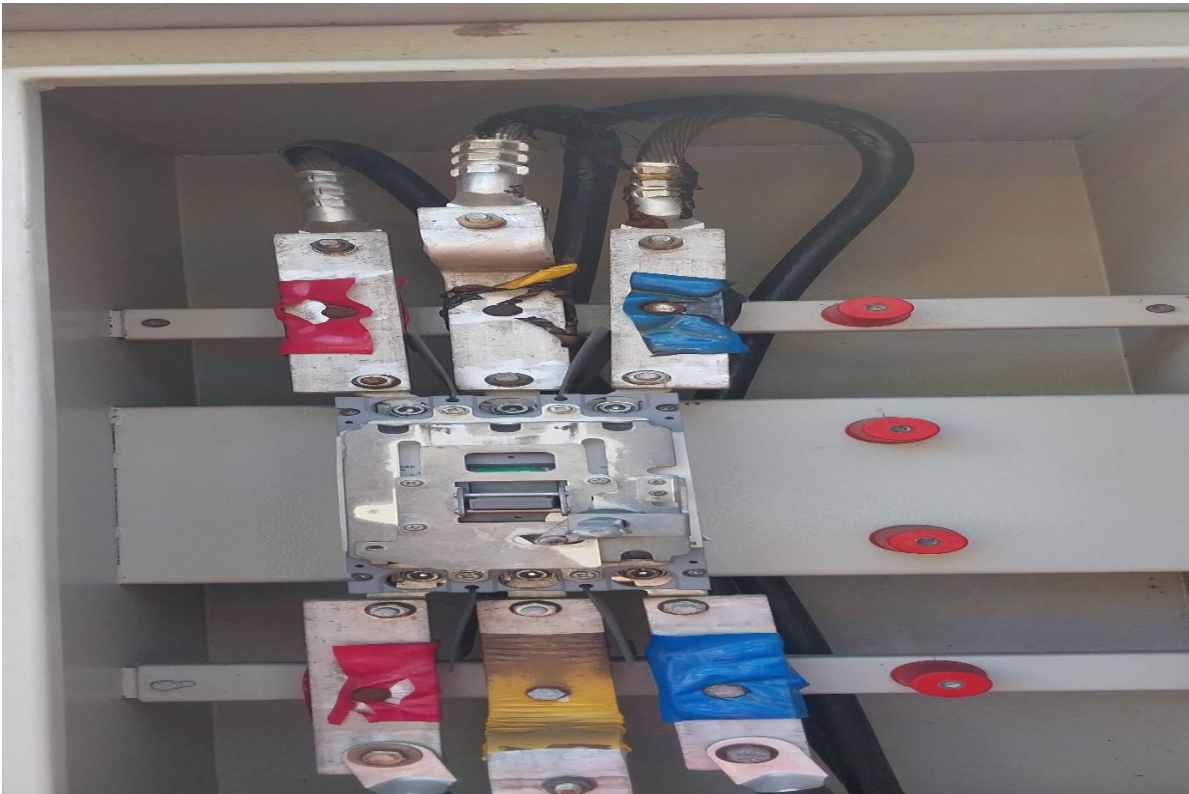
- ✓ In West Point and Clara Town, the LV cables and service drops are poorly done.
- ✓ Most of the LV cables around the Low Voltage Distribution Box are being peeled; this is across all the feeders. This is hazardous for other team members who may not know, or for children who play with and around these LVDBs.
- ✓ In West Point, Slip Way, and Clara Town, there are lots of damaged or rotten LV poles.
- ✓ Some of the LV cables used on the MCCB are of poor quality; as a result, these cables burn inside or outside the MCCB Box.

Brunt LV Cables Inside MCCB Box

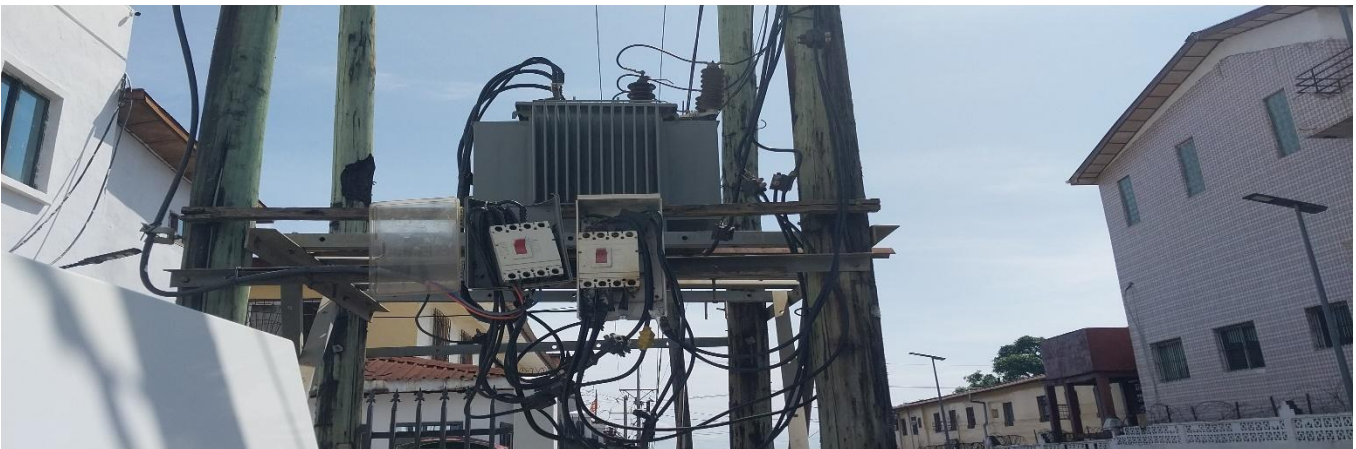
Damaged Transformer Breaker Enclosures

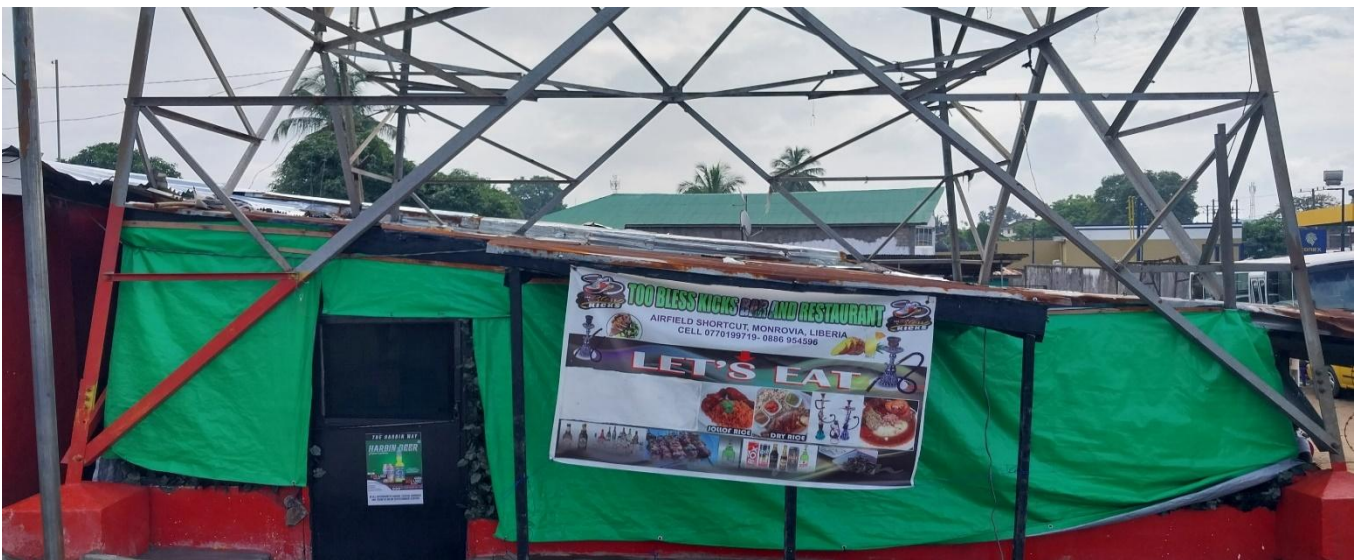
- ✓ On 15th Street, at ECO Hotel, 66 kV lines passing over a structure raising safety concern.
- ✓ In Wroto Town, Air Field Short Cut, structures are being constructed between the tower footings.
- ✓ On the Stockton Creek - Capitol 66 kV around Crown Hill, the underground 66 kV was stolen, and some tower members were removed/stolen.

Structure Built in Tower Footing along Airfield Short Cut

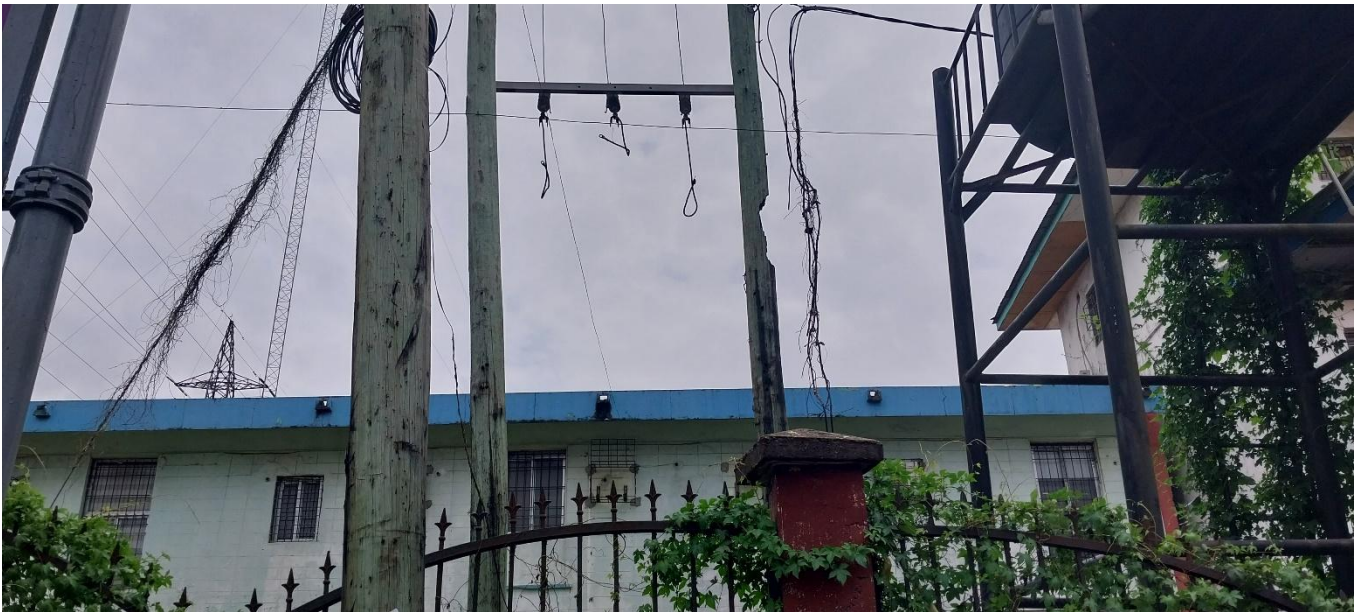
Old Transformer Structure at the old Health Ministry

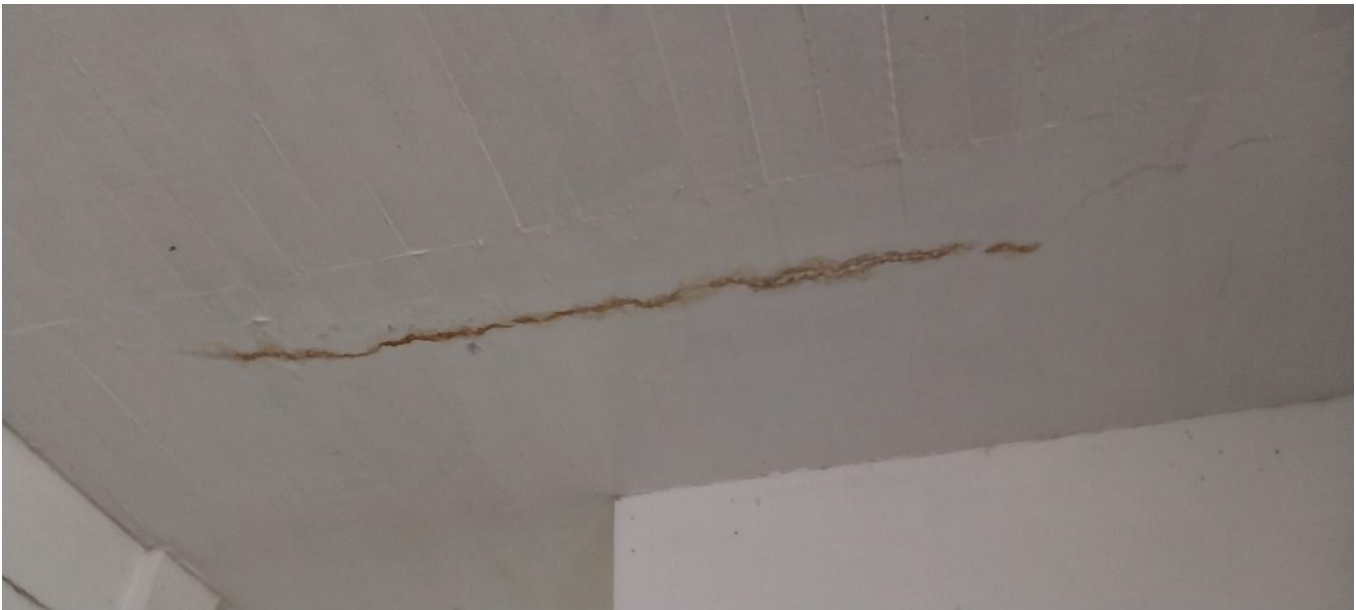
Leakage Roof Slab in Control Room

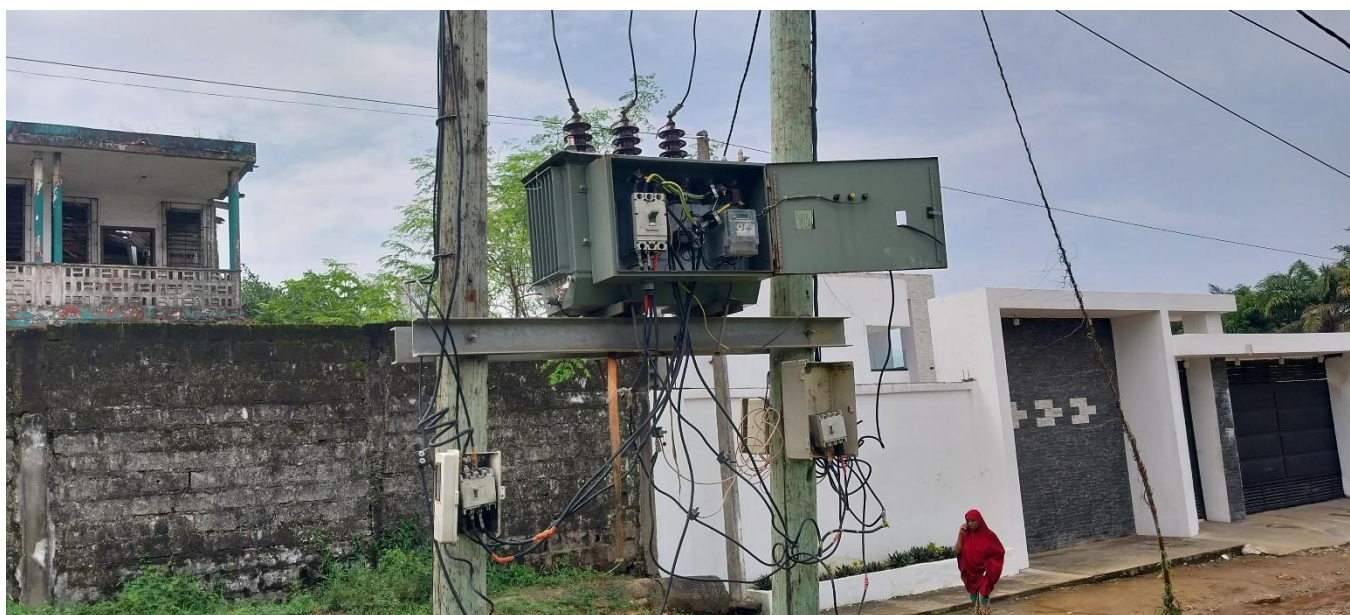
Damaged Transformer Breaker Enclosures

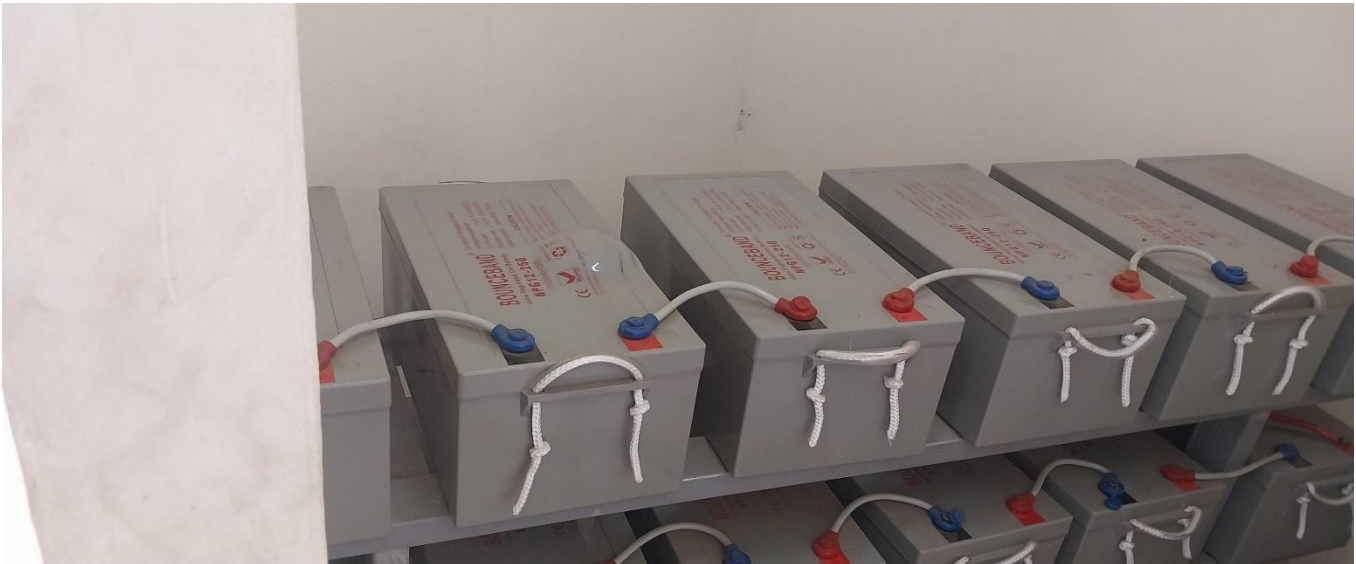
Battery Swelling

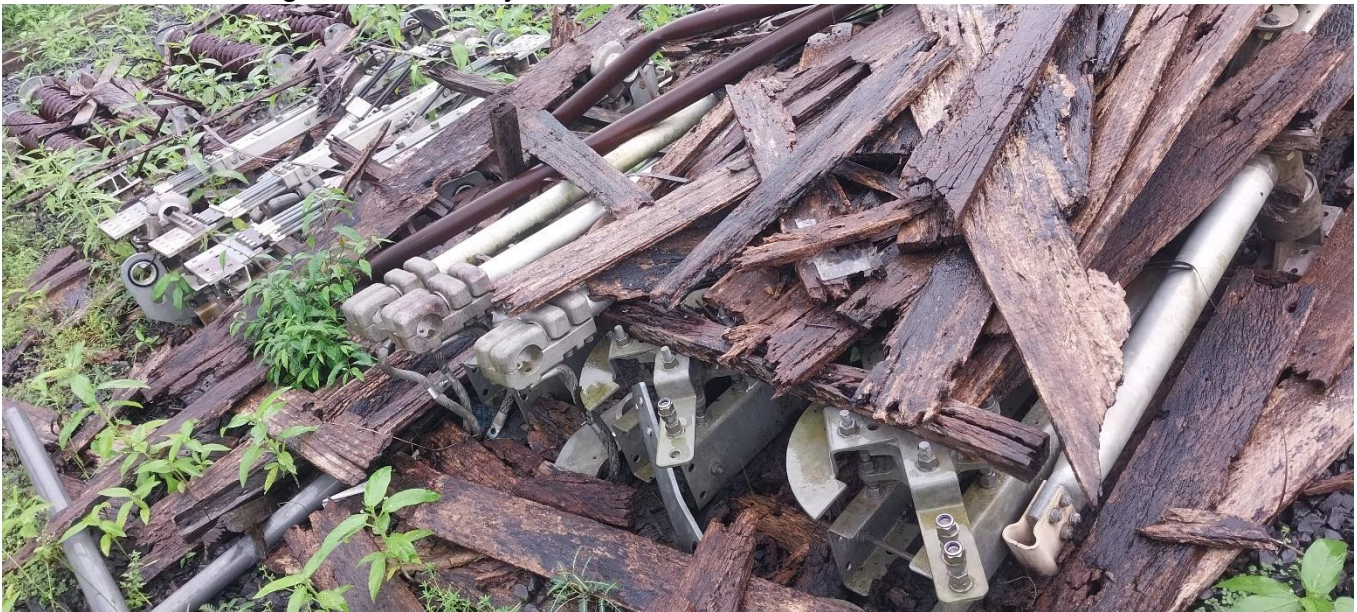
- ✓ The office and kitchen in the control building are unclean and are not equipped.
- ✓ Some staff members have not gotten first aid training.
- ✓ Spare materials are not properly stored; they are exposed to the rain and sun.
- ✓ The station lacks adequate security; due to the lack of manpower, the substation operates without security on Saturdays and Sundays.
- ✓ There are no lights in the security booths at the control building and the spillway.
- ✓ Operators complained of the storage of the monthly water and tea supply.
- ✓ The Substation lacks janitorial staff; as a result, the bathroom and everywhere are unclean.
- ✓ There are lots of millipedes (thousand legs) in the control room.
- ✓ There is no light in the battery bank room.

Spare Materials at Mt. Coffee Substation

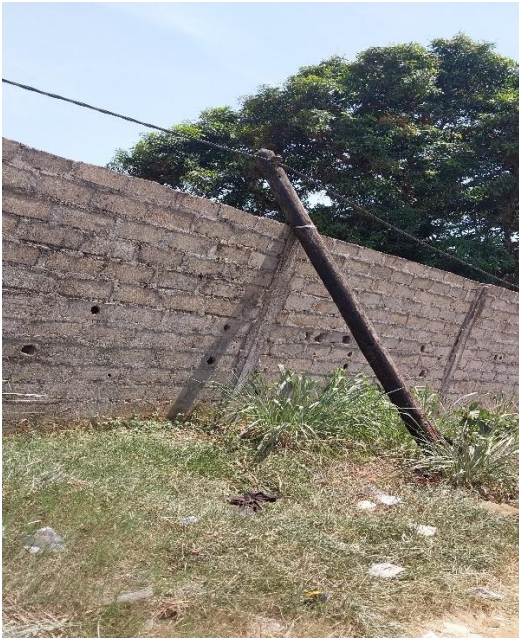
Leaning LV Pole

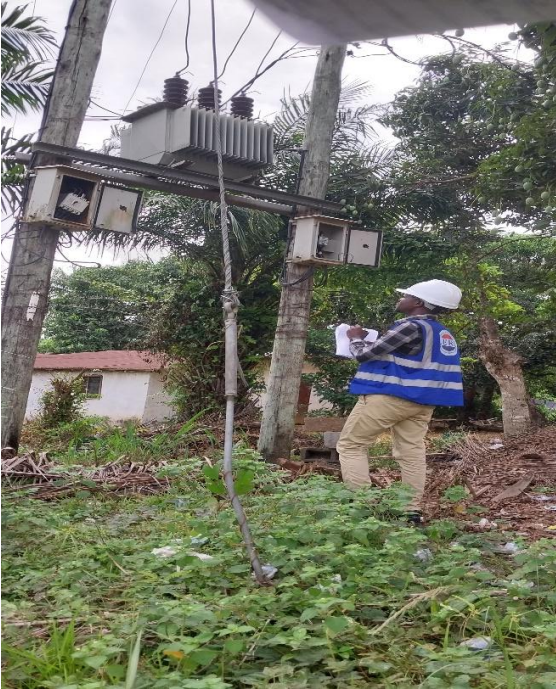
Damaged Transformer Breaker Enclosures
