Liberia Electricity Regulatory Commission

LIBERIA ELECTRICITY CORPORATION DISTRIBUTION SERVICE AREA (MONTSERRADO COUNTY) INSPECTION REPORT

The Technical Regulations Directorate (TRD)

August 2025

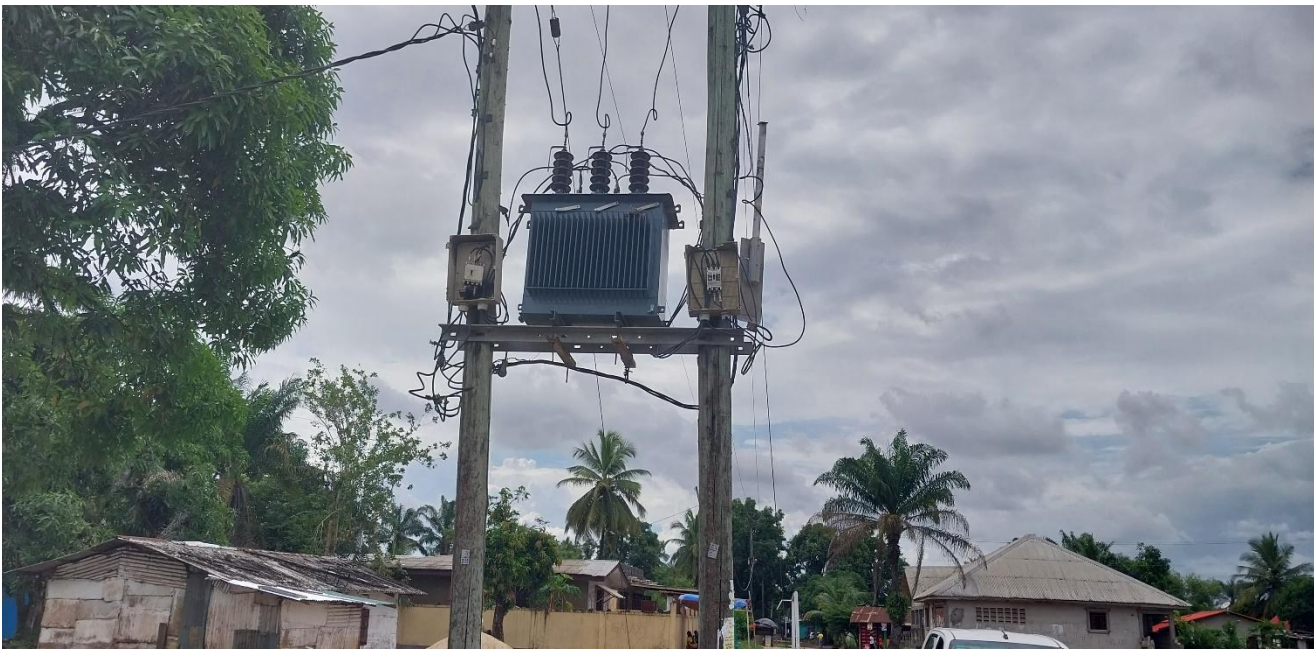
Badly Leaning Transformer with Damaged Transformer Breaker Enclosures

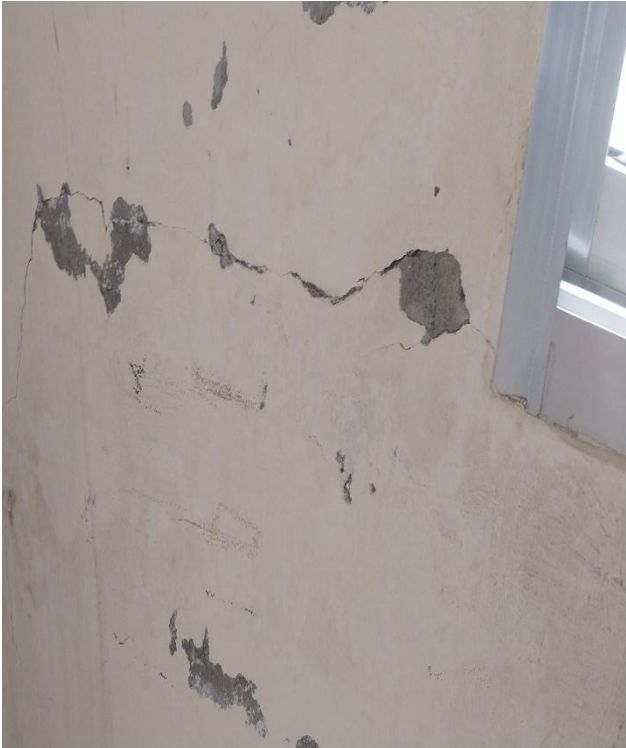
Crack on Stockton Creek Control Building

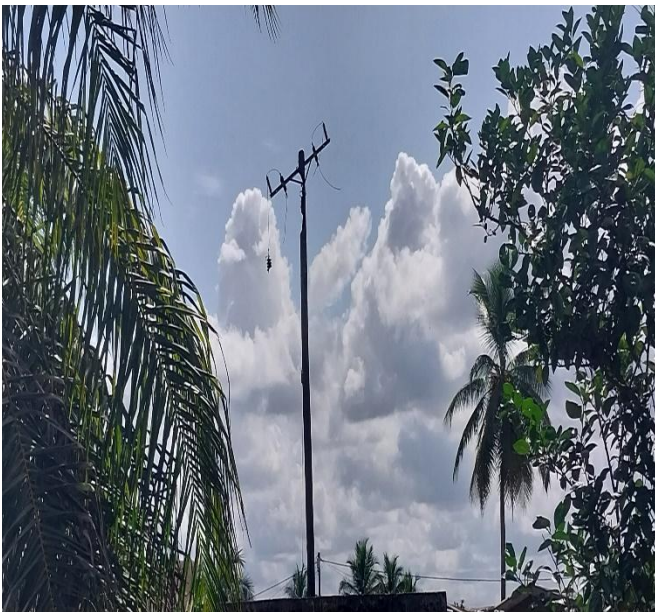
De-commissioned MV Pole

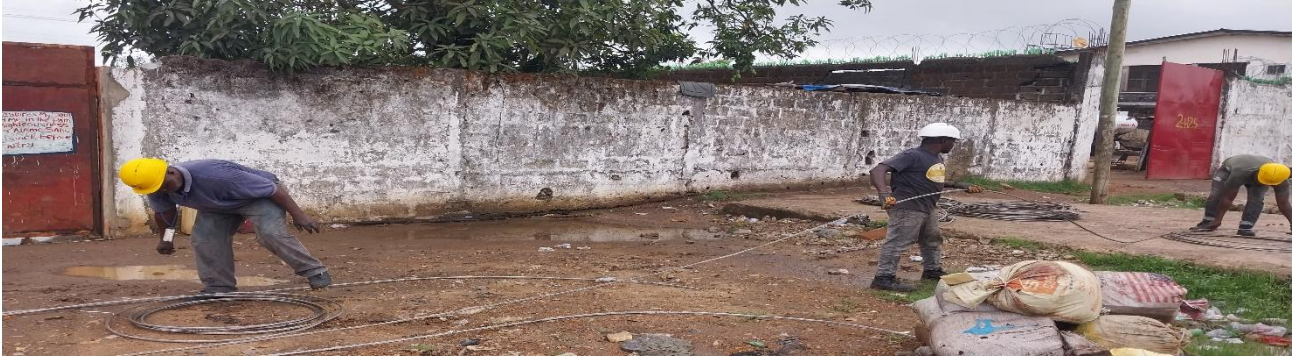
De-stringing 22 kV Lines

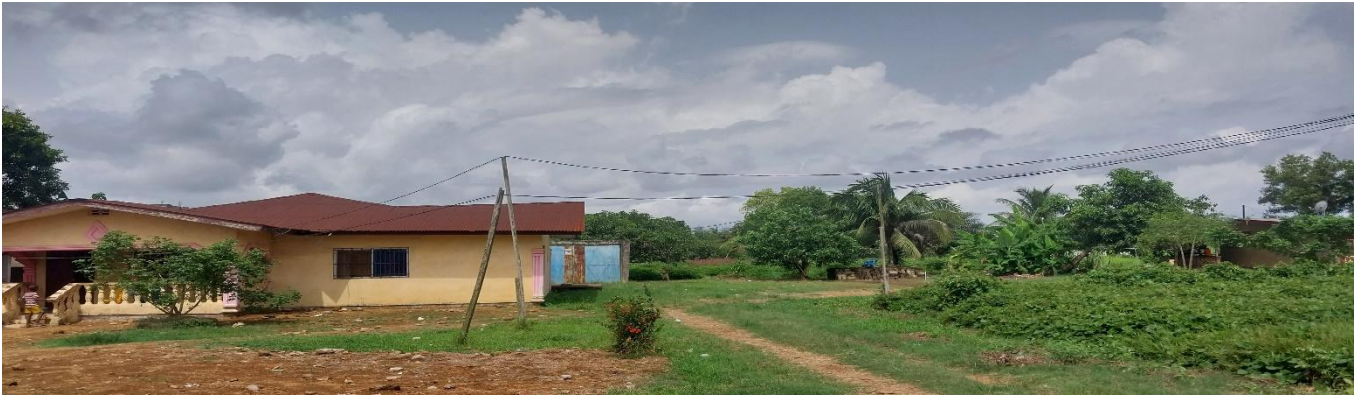
Poor Service Drops

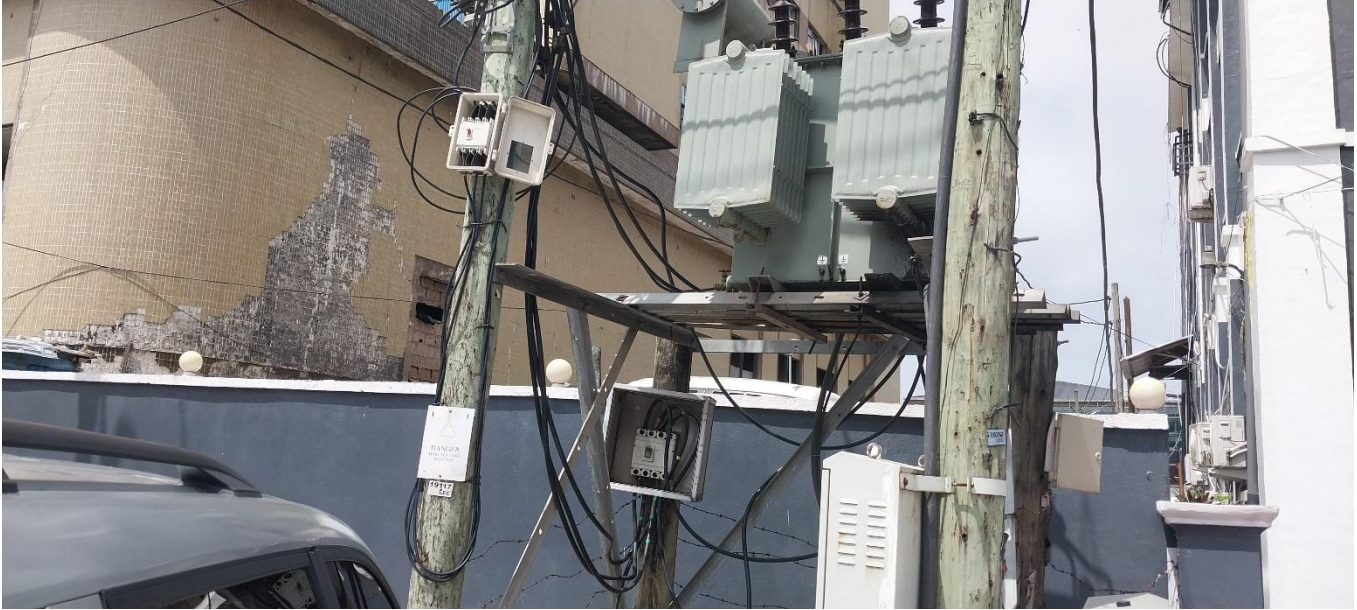
Damaged Transformer Breaker Enclosures

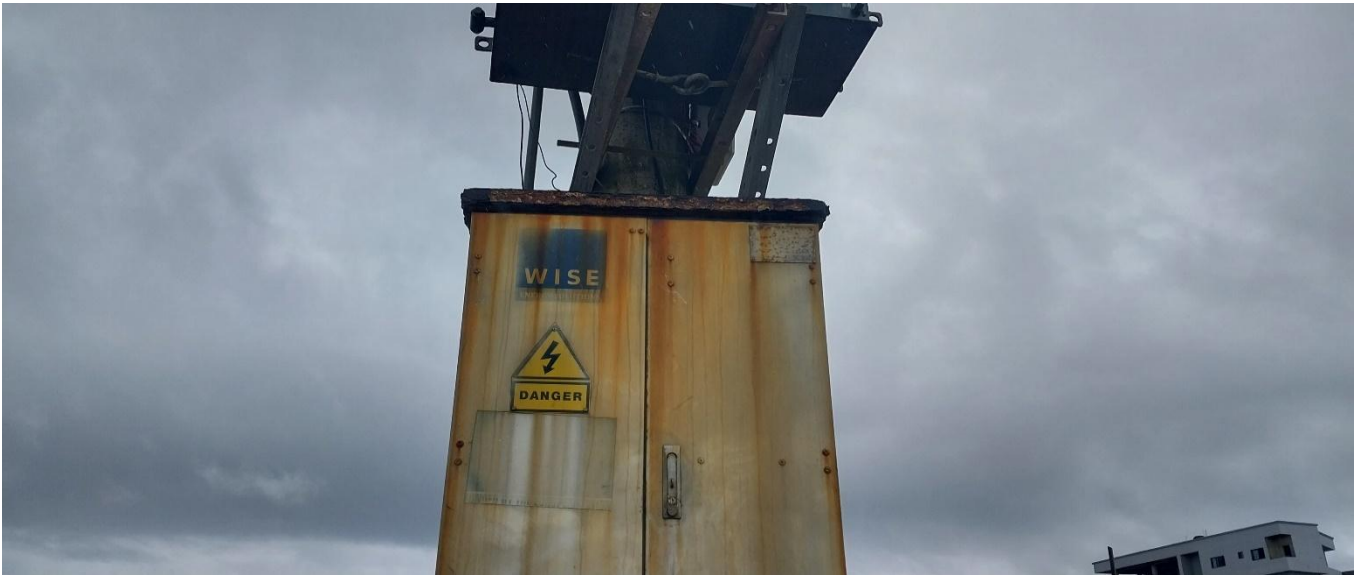
- ✓ The Low-Voltage Distribution Boxes along the coastal belt are rusting.

Rusting Low-Voltage Distribution Box Along the Coastal Belt

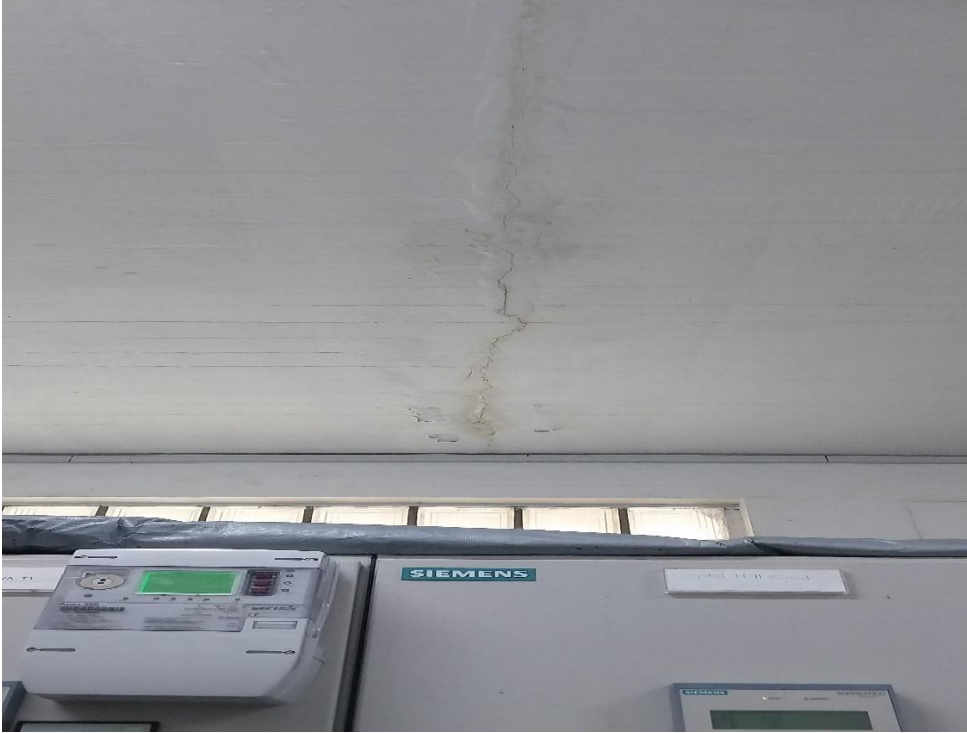
Leakage Over 22 kV Switchgear

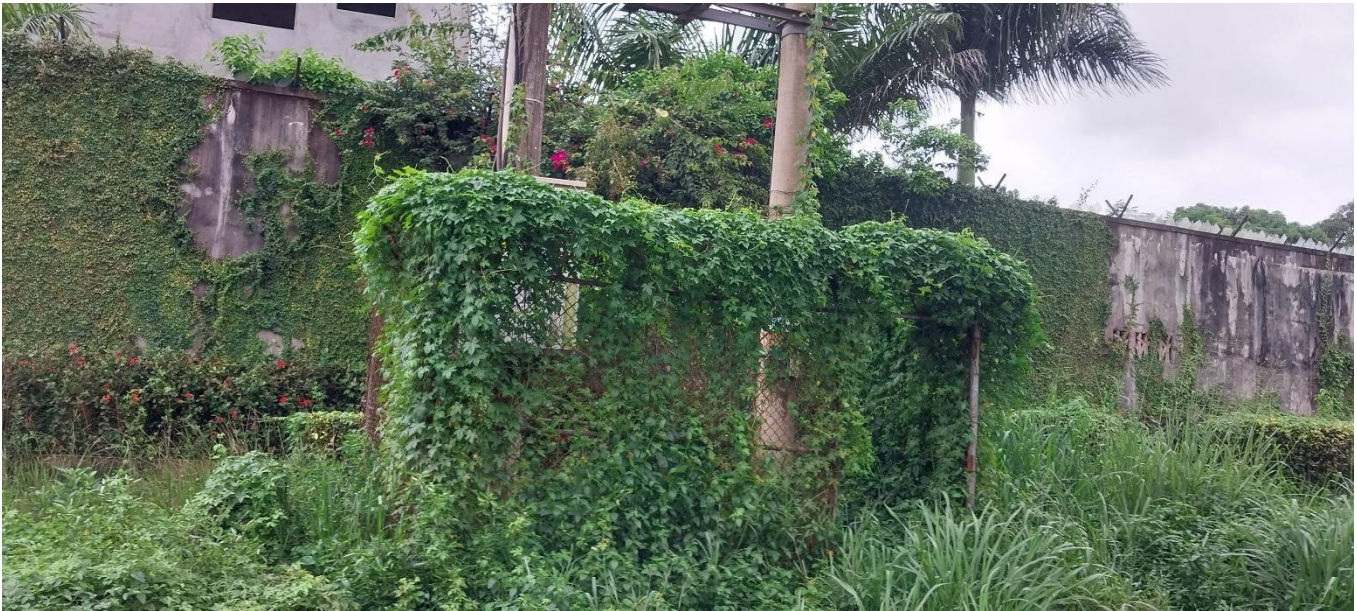
Vegetation at Transformer Station

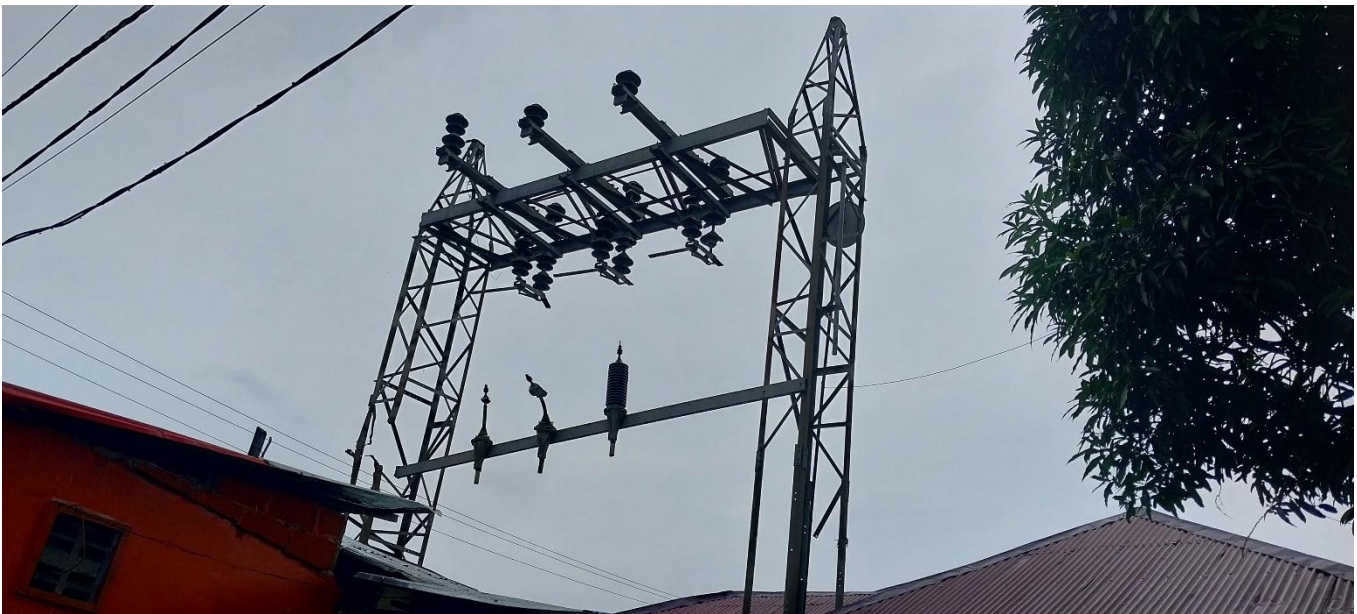
Old Gentry Structure at Kalindo-Old Road

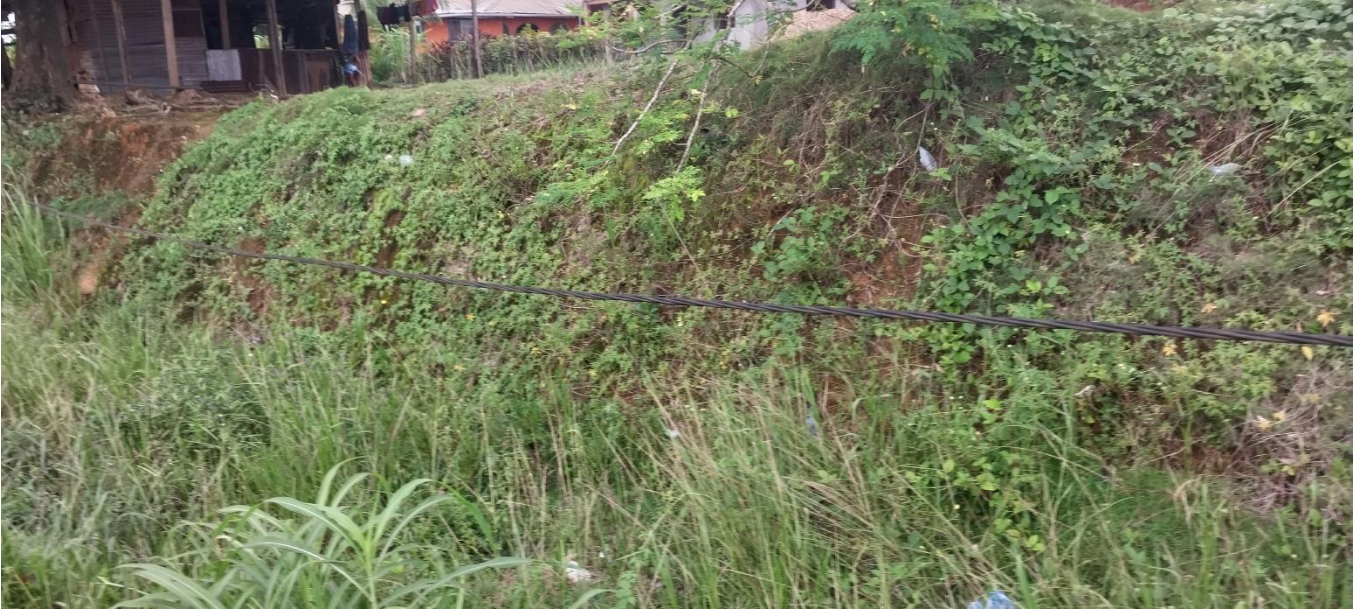
Low Bundled Conductor

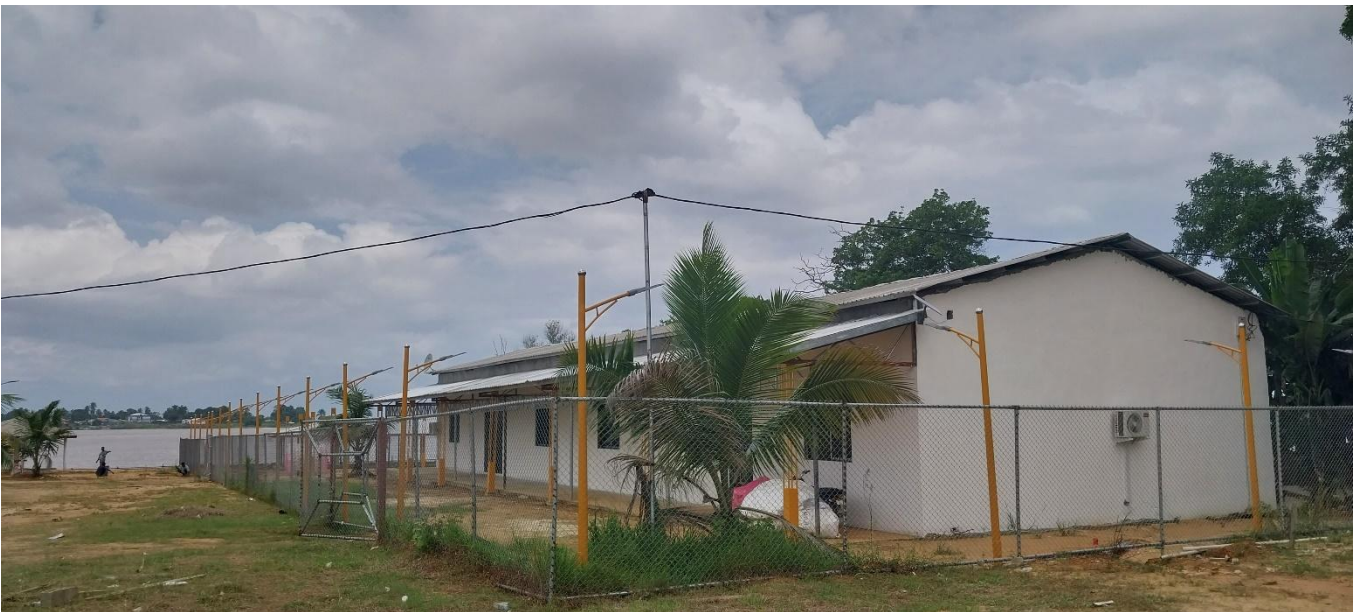
LV Strung on Metal
