# **Liberia Electricity Regulatory Commission**

## **LIBERIA ELECTRICITY CORPORATION Distribution Service Area (Bomi & Cape Mount Counties) Inspection Report**

**March 2025**

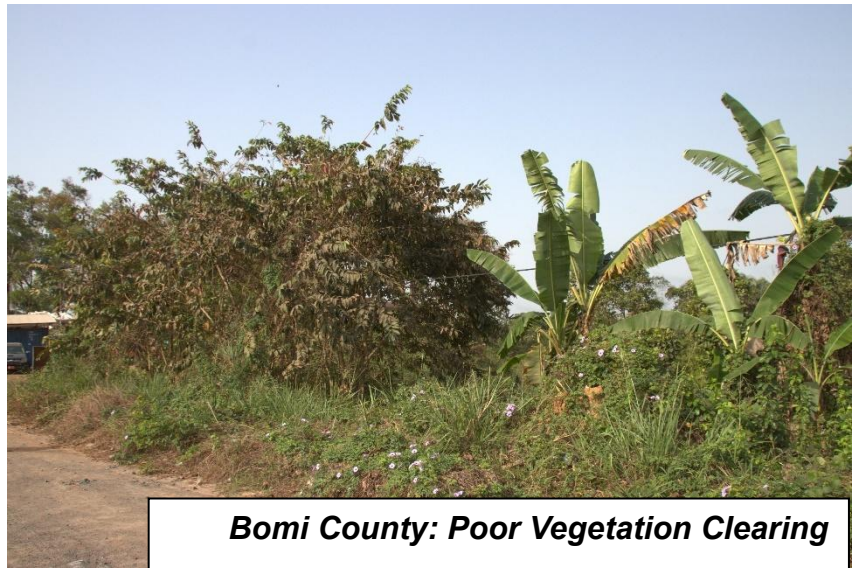
- ✓ Encroachment in the right of way (ROW) on account of new construction works.
- ✓ Poor Vegetation Clearing management.
- ✓ At monopole #94, the pole foundation is being hugely undermined due to excavation.
- ✓ Many guys/stays are damaged/removed in the Virginia to Kle corridor, leaving many poles structures mechanically unstable.

- ✓ It was noticed that most of the monopoles in the corridor are experiencing foundation failure. Notably, monopoles numbers 368 to 374 are leaning resulting in low clearances posing a safety risk, and
- ✓ Indiscriminate startup of bush fires along line corridors.

| 4 | Po River – Sass Town | Monopole (364 – 374) foundation failure. | Construct new foundations | June 2025 |

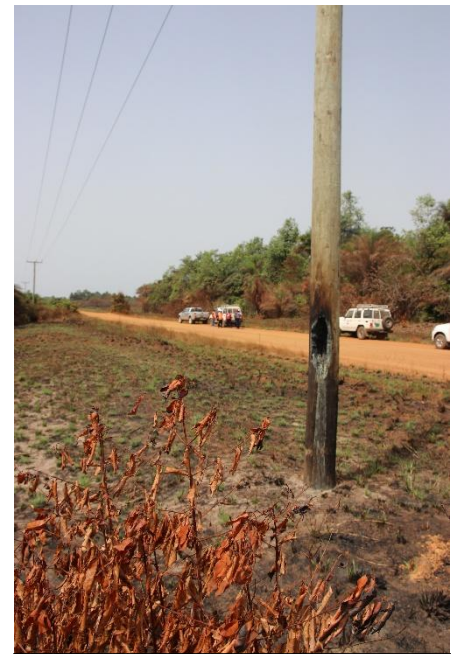
***Wooden pole damaged by bush fire***

| 5 | Po River – Tubmanburg – Robertsport – Bo Waterside (Bomi & Cape Mount) | Indiscriminate startup of bush fires. | Accelerate the replacement of wood poles to concrete & steel poles. | January 2026 |

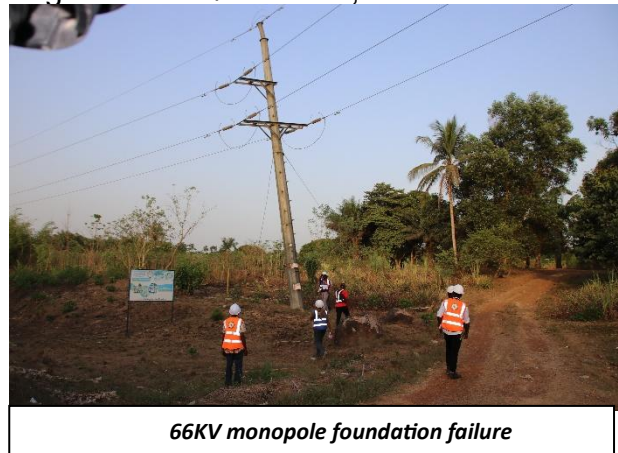
*66KV monopole foundation failure*

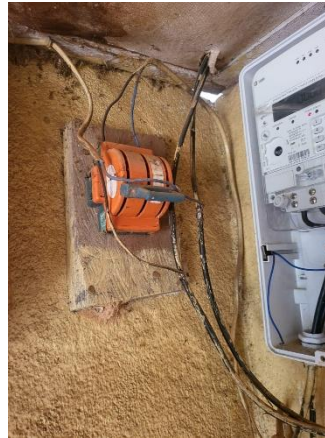
- ✓ Meters installed at customer's premises are largely bypassed.

*Wood shop engaged in power theft in Grand Cape Mount County*

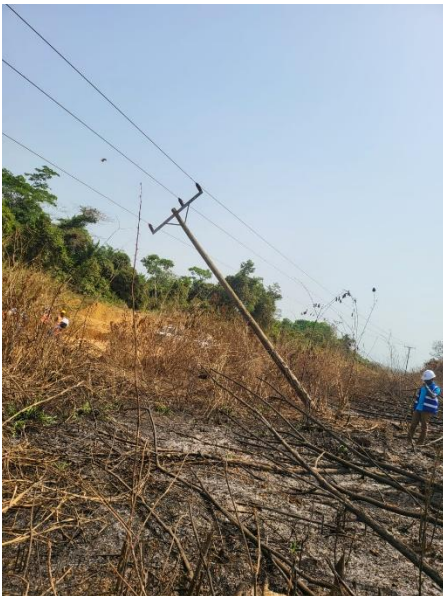
*Damaged pole by bush fire*

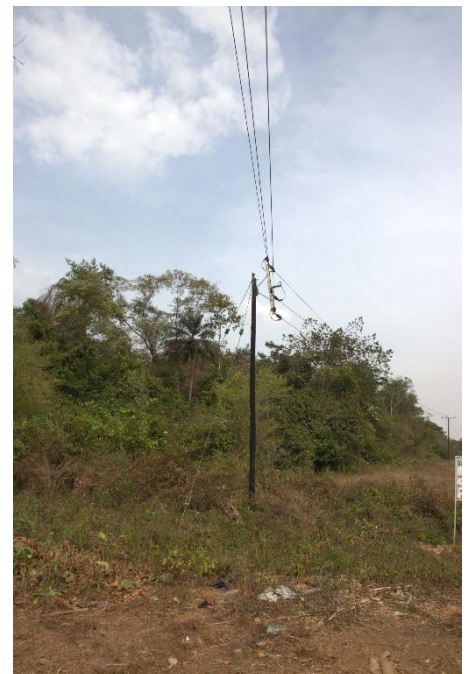
*Damaged MV pole in Grand Cape Mount County*

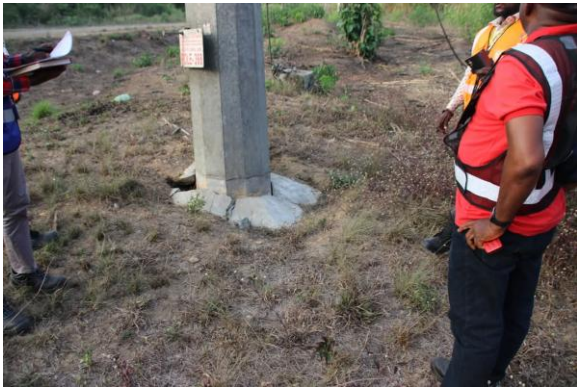
**66KV monopole foundation failure**

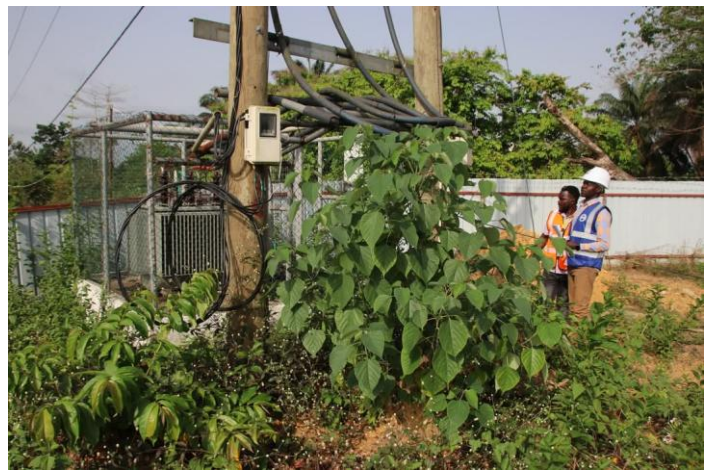
**Bushy transformer**

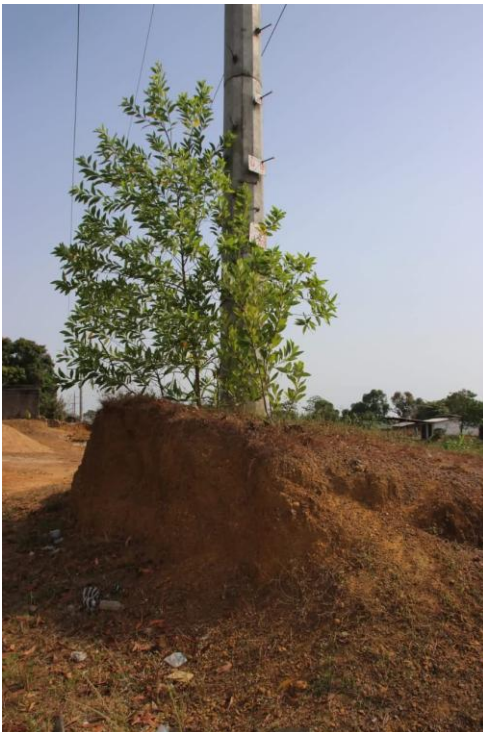
**Dirt miners undermine a 66KV monopole**

| 3 | Po River – Kle Sub | Pole #94 foundation undermined. | Backfill foundation | May 2025 |

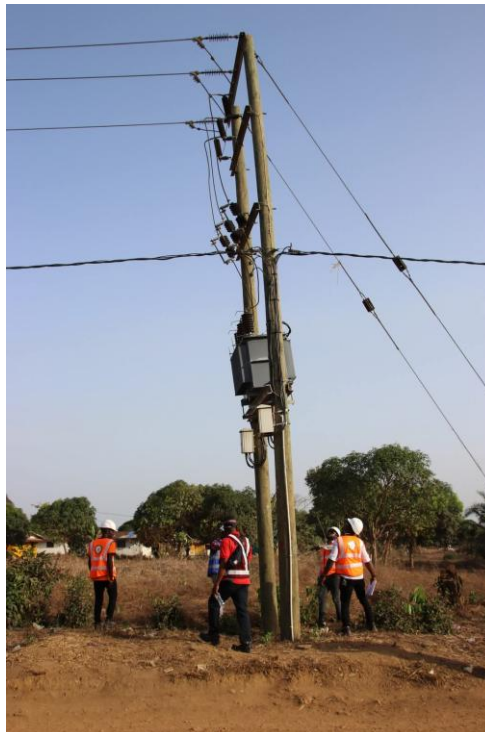
- ✓ One leaning transformer was found between the Po River and Kle Substation (Sass Town) and another one between Tubmanburg and Western Cluster.
- ✓ Lack of energy monitoring meters on all transformers for energy accounting and load analysis.
- ✓ Loose/damaged transformer earthing in some areas puts pedestrians at risk in Bomi and Cape Mount.

**Leaning transformer poles**

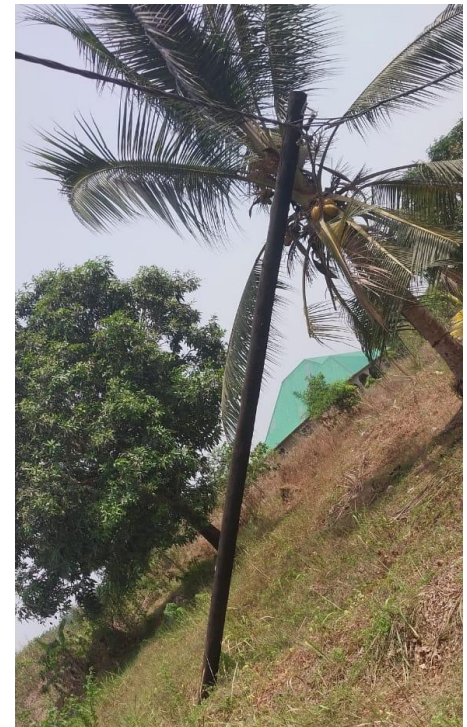
**Leaning LV pole**

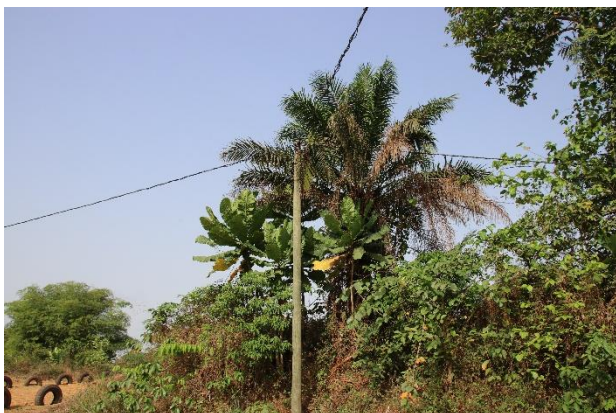
**Vegetation interferes with LV line**

1. That the Commission mandates LEC to fully implement Vegetation clearing under all existing 66kV High Voltage and 33kV medium voltage lines. The deployment of Power saws and earth-moving equipment replacing cutlasses at this point is highly encouraged.
2. That LEC accelerates its action of replacement of all wooden poles with concrete or steel poles in the Medium Voltage distribution network due to high vulnerability to indiscriminate bush fire startup. It is recommended that all future rural MV networks comprise only concrete poles or steel poles to mitigate the risk to bush fire.
3. That all bypassed meters be normalized to enable energy accounting and improve revenue generation.

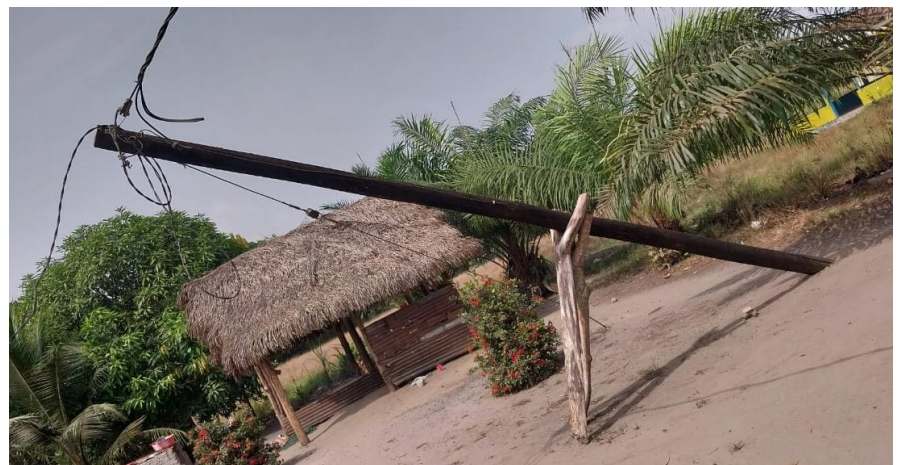
**Damaged LV pole in Boimi Town, Robertsports Highway in Grand Cape Mount County**
