# **Liberia Electricity Regulatory Commission**

## **LIBERIA ELECTRICITY CORPORATION Distribution Service Area (Margibi County) Inspection Report**

**March 2025**

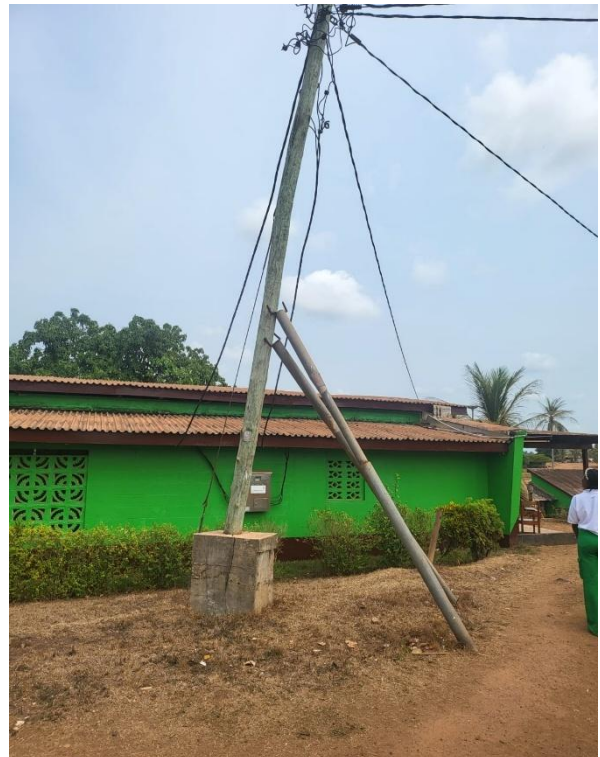
**A broken LV pole**

| No. | Location | Defect | Action Required | Completion Date |
|---|---|---|---|---|
| 2 | KRTTI Campus | Badly leaning LV Pole | Replace Pole | By April 15,2025 |

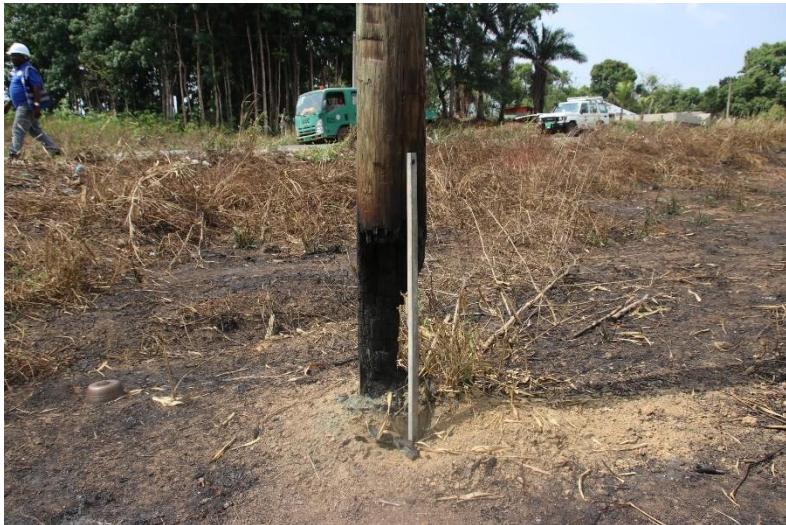
- ✓ Indiscriminate startup of bushfires along line corridor leaving the network comprising mostly of wooden poles vulnerable and undermining system reliability. There are evidence of several burnt poles along the Kakata to Weala corridor,

**A pole damaged by bushfire**

| No. | Location | Defect | Action Required | Completion Date |
|---|---|---|---|---|
| 1 | Kakata City; Kakata- Weala corridor | Burnt poles and rotten poles | Replace with concrete poles or steel poles. | By April 15,2025 |

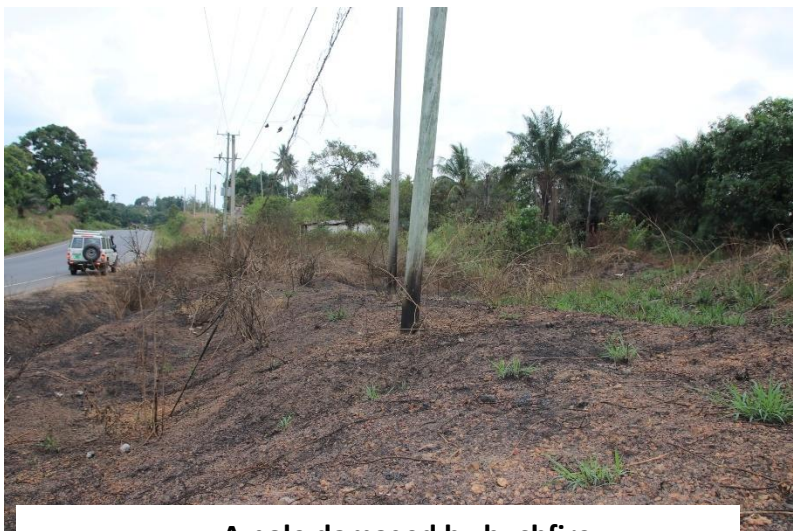
**A pole damaged by bushfire**

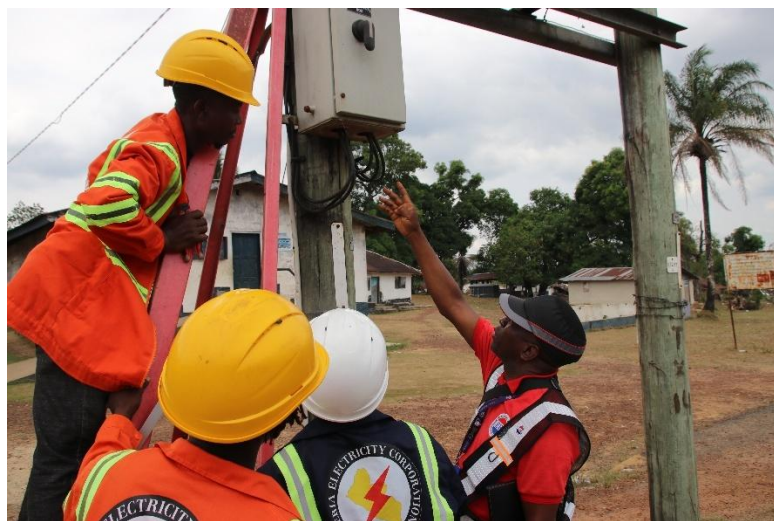
- ✓ Vegetation in the transformer station at Arrow Alliance Group along the Kakata to Gate 15 corridor and the Kakata General Market.
- ✓ Secondary low voltage breaker enclosures have become an attraction for birds nesting at most of the transformer locations.

**The team inspects a breaker with bird nest**

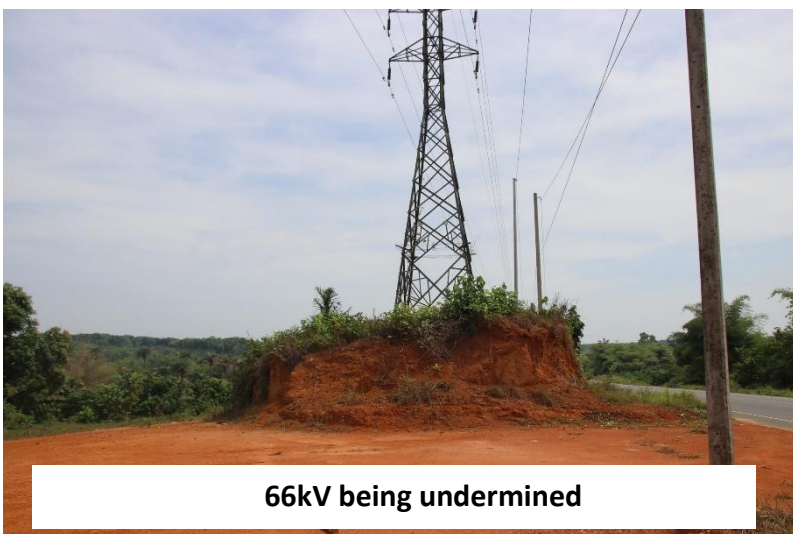
**66kV being undermined**

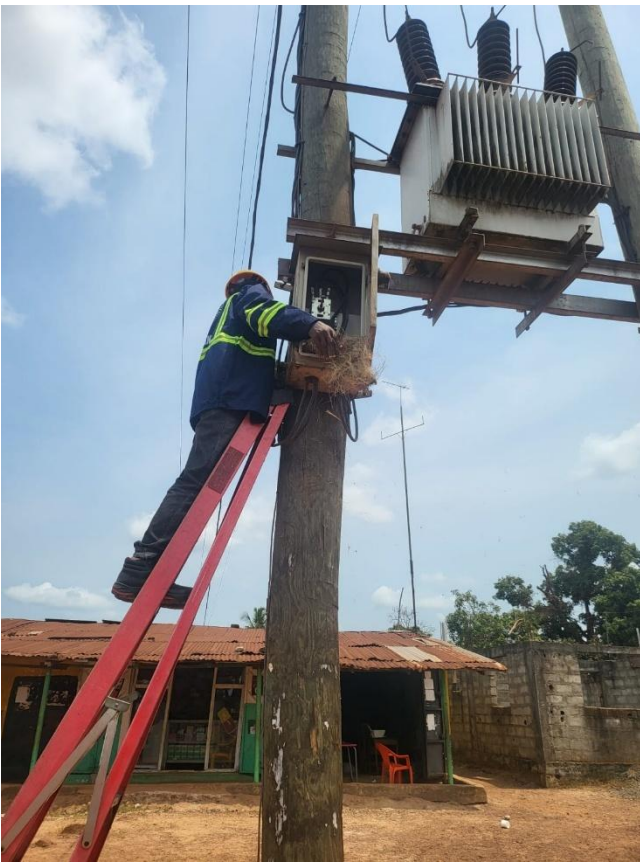
**A technician removes a bird nest from a breaker**

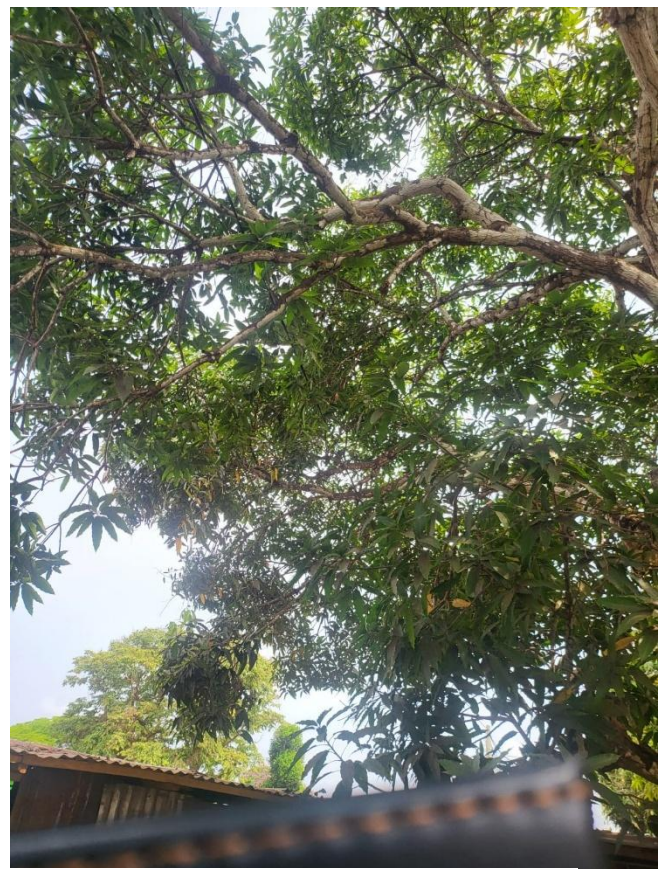
**A LV line in a plum tree**

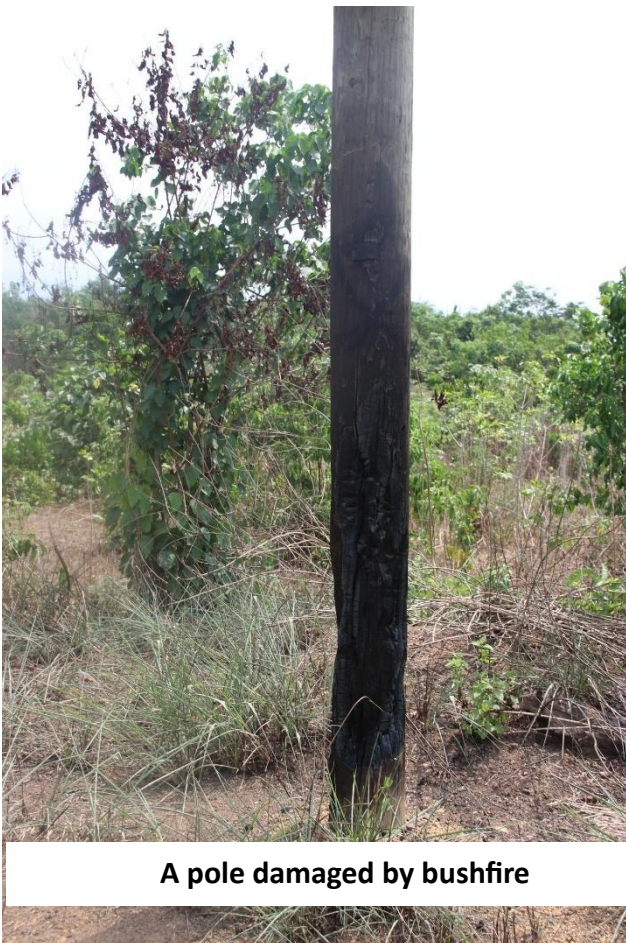
**A pole damaged by bushfire**
